**SCIENTIFIC, TECHNICAL AND
ENGINEERING WORK TO ENSURE
THE SAFETY OF THE FORMER
SEMIPALATINSK TEST SITE**

Volume I

The first volume presents the results of scientific, technical and engineering work to ensure the safety of the former Semipalatinsk Test Site, also known as the *Polygon*, performed between 1994 and the present day by the National Nuclear Centre of the Republic of Kazakhstan, in collaboration with representatives of the United States of America and the Russian Federation. During the course of the work the nuclear testing infrastructure was abandoned and large-scale measures were implemented to mitigate the proliferation risks of weapons of mass destruction and prevent access to nuclear waste within the test site. The results of work on mitigating proliferation risks were given a high rating, as stated in a joint declaration by the presidents of Kazakhstan, Russia and the USA, pertaining to their collaboration at the former Semipalatinsk Test Site, made at the Nuclear Security Summit in Seoul on 27 March 2012.

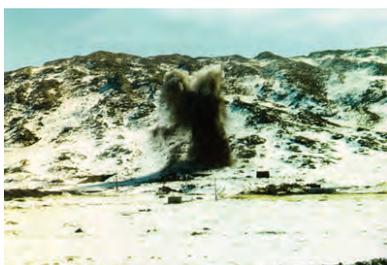
Figure 2.3. Tunnel No. 192 (blast)

Three days after the closure of the tunnel by blasting (*Figure 2.3*), the entrance section had been landscaped, returning the natural relief of the locality (*Figure 2.4*).

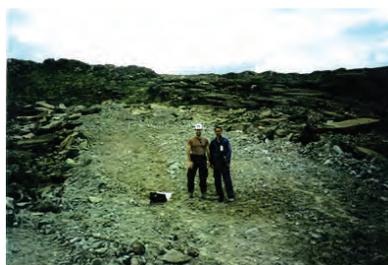
Figure 2.4. Tunnel No. 192 (after backfilling of the entrance)

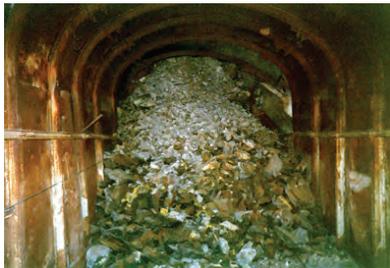
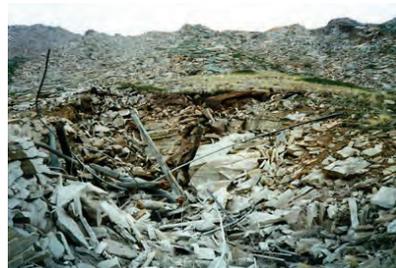
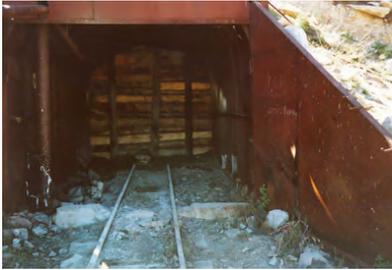
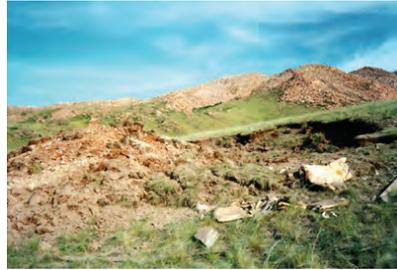
Boring - blast from inside

Boring - blast from outside

Concrete plug

Pressure charge

Figure 2.6. Tunnel closure methods at Degelen Mountain

The photographs (Figure 2.6) indicate some of the main methods used to liquidate the tunnel entrances.

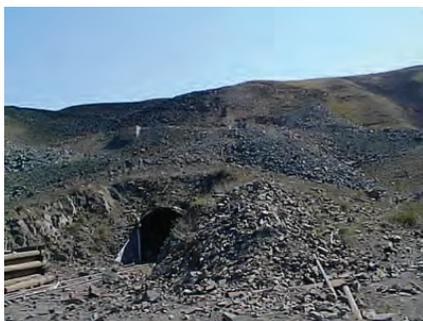
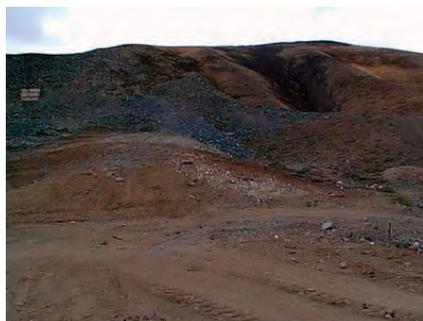
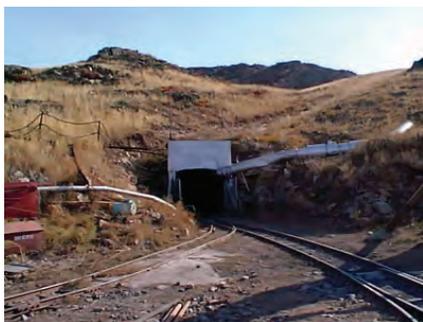
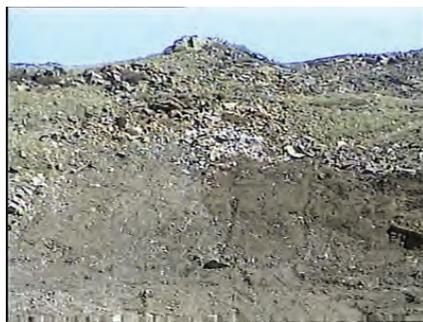
Tunnel No. 160

Tunnel No. 214

Figure 2.8. Tunnel entrance type before and after backfilling

Each stage in liquidation of the tunnel entrance concluded with backfilling of the trench or crater that formed after the blasting work and levelling to reinstate the natural relief (*Figure 2.8*).

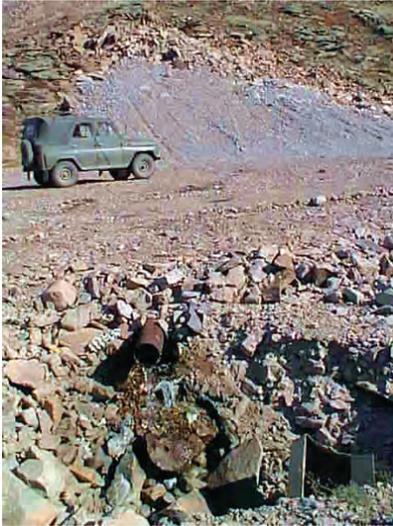
Figure 2.9. View of Tunnel No. 503 section

Filters were installed at the entrances to ten tunnels that had a continuous flow of water: crushed aggregate was added by the former entrances to tunnels 156-T, 504 and 503 in areas measuring 30 x 30 m, and then levelled (*Figure 2.9*); trenches were dug

by tunnels A-1, 165, 176, 177, 609, 511 and 104, drainage pipes were laid and then filled with coarse, crushed aggregate and levelled (*figures 2.9 and 2.10*).

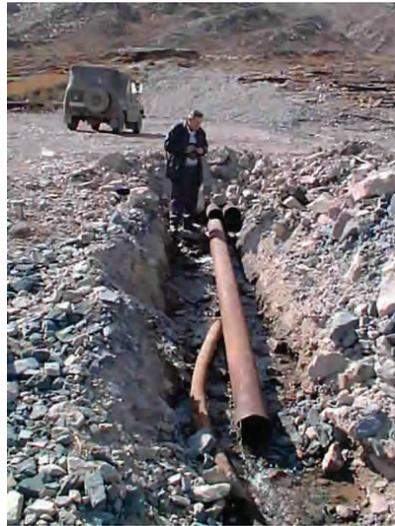
Figure 2.10. Filter structure by entrance to Tunnel No. 176

The examination of these tunnels in September 2000 indicated that the filters at five of the entrances ensured complete absorption of the water in the rock dump. By increasing the thickness of the crushed aggregate by the entrances, water flows from tunnels A-1, 156-T and 165 were completely isolated. At the tunnel entrances where the flow intensity exceeds 200 L/min, the water washes the channels and reaches the nearest valley. Under a high intensity, the water quickly saturates the rock dump, resulting in waterlogged areas forming around the dump (Tunnel No. 504).

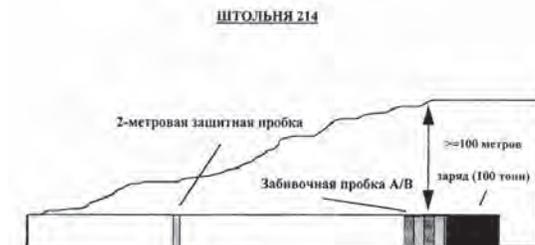
Blast diagram

Figure 2.11. Tunnel No. 214

The research programme for preparing the Omega experiment in Tunnel No. 214 (*Figure 2.11*) included a package of work pertaining to the geological, geophysical and hydrogeological examination of the tunnel, to assess the background medium of the calibration blast and to develop the charge design to satisfy the blast requirements.

The preparatory work was completed by charging the explosive chambers, positioning the measuring instrumentation in the tunnel and at the surface and forming the concrete plugs (*Figure 2.11*).

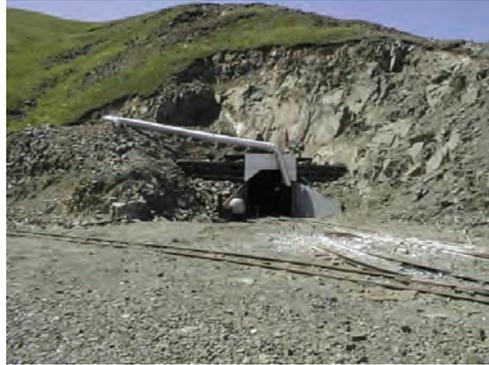
Figure 2.14. Entrance of Tunnel No. 160-C

Tunnel No. 160-C was constructed to run parallel to Tunnel No. 160. The centre of the blast chamber was located at the survey mark at 230 m, 25.96 m higher than it and 26.0 m to the east of the tunnel axis (*figures 2.13 and 2.14*). The tie-in point had an absolute elevation of 660.8 m. The true bearing of the direction of the tunnel axis was 182°. The tunnel, including the blast chamber, was 94.3 m long.

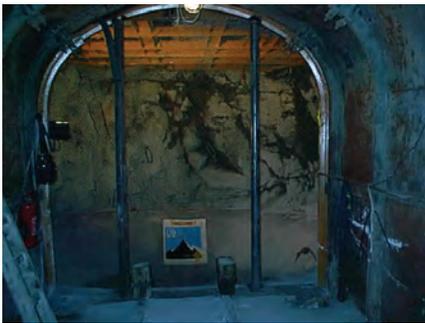
Figure 2.15. View of the blast chamber

The 100-tonne Granulotol charge with six booster primer-detonators was placed both in packaged and in loose form into a specially built blast chamber, forming a hemisphere in its lower part (*Figure 2.15*). The radius of the hemisphere stood at 3 metres. The dimensions of the chamber during the drilling process stood at 4.8 x 4.8 x 4.8 metres.

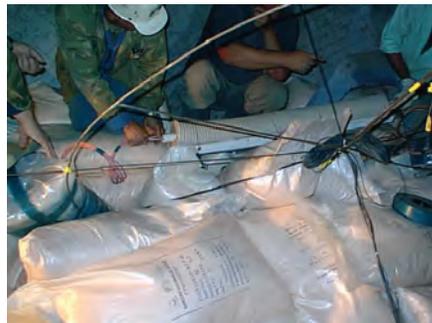
Figure 2.16. View of the blast chamber with measuring sensors, primers and template

Sensors for measuring detonation speed were placed in the blast chamber at the same time as the explosive (*Figure 2.16*).

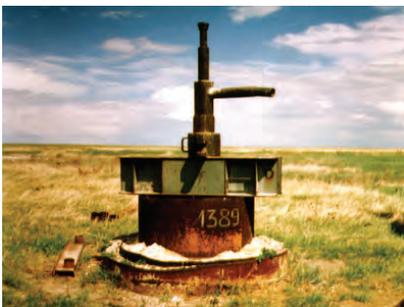
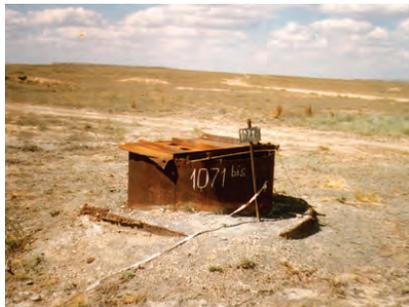
Borehole No. 1389

Borehole No. 1071-bis

Figure 2.22. Heads of boreholes at the Balapan Area

To give stability to the borehole, steel pipes were used with a 2,100-mm diameter and 16-mm wall thickness, a 1,640-mm diameter and 14–15-mm wall thickness, a 1,440-mm diameter and 12–14-mm wall thickness, a 1,020-mm and 820-mm diameter and 10–12-mm wall thickness.

All borehole casing was brought to the surface and forms the head of the borehole (*Figure 2.22*). The spaces between the pipes are filled with mortar.

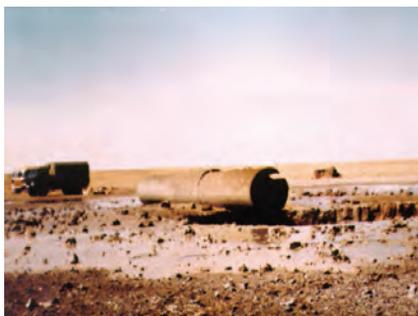
Figure 2.24. Borehole No. 1381 after the blast

The blast produced a crater up to 3.1 metres deep from the earth surface. The maximum diameter of the crater at the elevation of the earth surface was 10 metres; 20 m³ of rock was discharged. As a result of the blast, a 15-m long fragment of the casing string was thrown 1.5 metres from the centre of the former borehole (*Figure 2.24*).

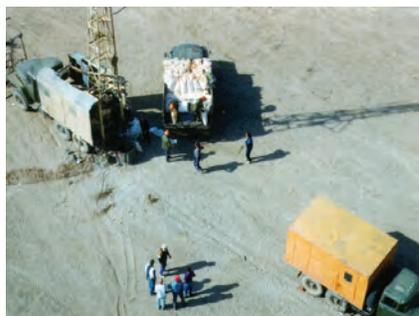
Figure 2.25. Borehole No. 1349 Laying the explosives

The main Granulotol charge with a 22,000-kg mass (*Figure 2.25*) was fabricated on 30 August 1997, 24 hours before the time set for triggering the charge. The containment vessel with the primers for the main charge was fabricated and lowered on 28 September, 2 hours before the blast. The design of the charge in the borehole is illustrated in *Figure 2.23*.

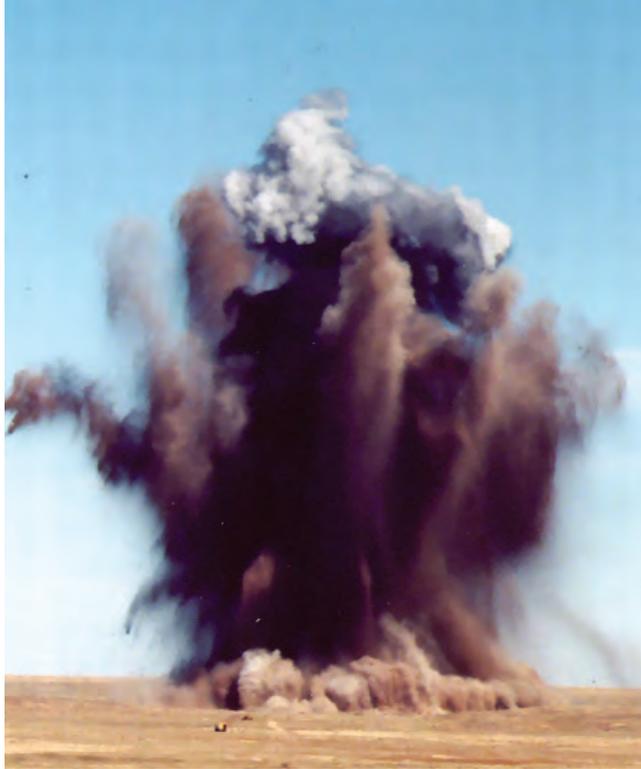
Figure 2.27. Fragment of the blast

A crater formed as a result of the blast (*Figure 2.27*) with a diameter at the upper part of the earth pile at 55 m and 18 metres deep (*Figure 2.28*). A total of more than 6,500 m³ of rock was discharged. Fragments of rock and pieces of borehole casing were thrown over 500 metres from the epicentre of the blast. Two days later the crater was filled with ground water to a 4.0-metre elevation from the previous earth surface.

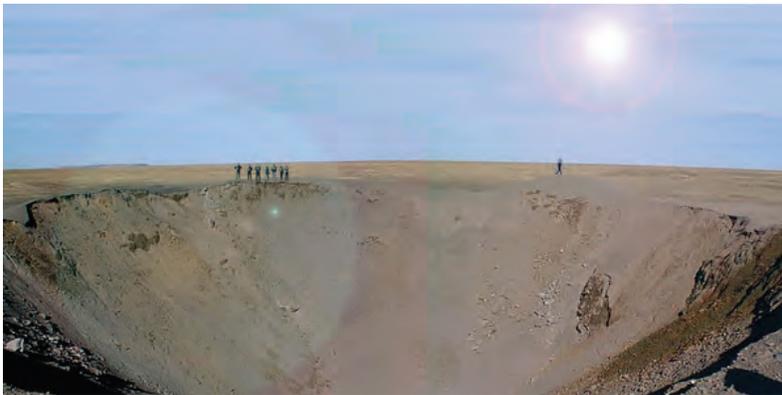
Figure 2.28. Crater after the blast at borehole No. 1071-bis

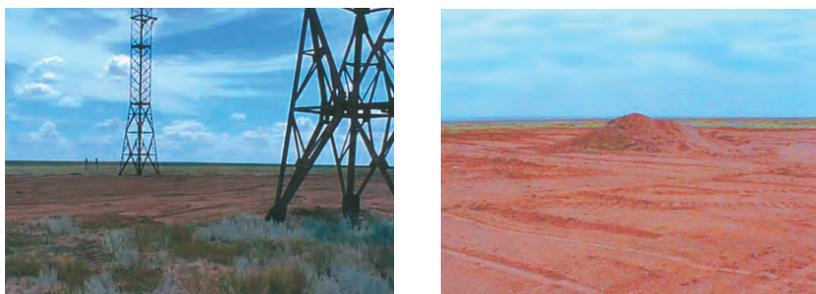
**Figure 2.29.** External appearance of the working area after levelling

At the end of the backfilling of the crater, the sector was levelled over an area of 100 x 100 metres (*Figure 2.29*).

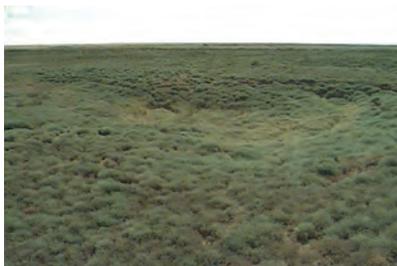
Figure 2.32. A typical depression in the vicinity of the silo launchers

The silo launcher sites are currently characterised by areas where the ground has subsided, most likely caused by internal cavities. These depressions take the form of circular hollows, scored with deep cracks that are circular and diametrically directed (*Figure 2.32*). Sometimes small pits of up to 50 cm in diameter and 1 metre deep are found in the centre or around the edges of the depressions. The depressions have various diameters, from several metres to several tens of metres (not usually more than 30 metres). In place of a former, unfinished silo launcher there is a circular depression, several metres deep, enclosed by the concrete wall structures of the former silo launcher (*Figure 2.33*).

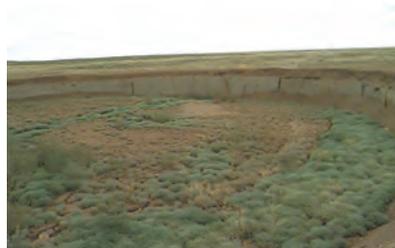
Figure 2.33. A circular depression in the site of an unfinished silo launcher

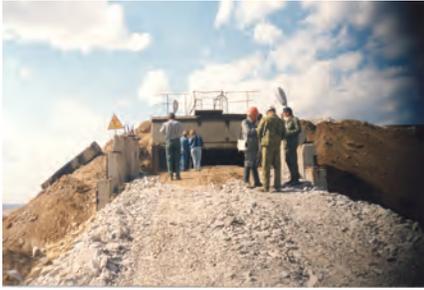
Figure 3.3. View of the special structure, housing the Kolba containment vessel

Site K-85 is located in the southern part of Degelen Mountain. The tested Kolba containment vessel is installed on a rail platform in an embedded concrete structure (a special structure), at the borehole head site, some 160 m from the tunnel entrance (*Figure 3.3*).

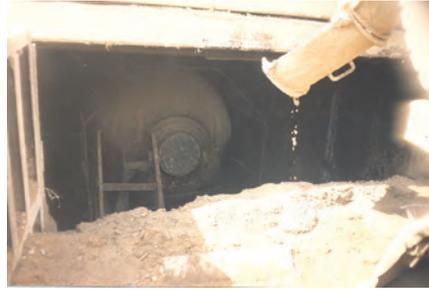
Figure 3.4. Concrete casing of the entire structure in which the Kolba containment vessel is housed

1. Opening the containment of the K-85 concrete structure and providing access to the Kolba containment vessel;
2. Preparation of the containment vessel for long-term storage;
3. Concrete casing of the entire structure in which the Kolba containment vessel is housed (*Figure 3.4*).

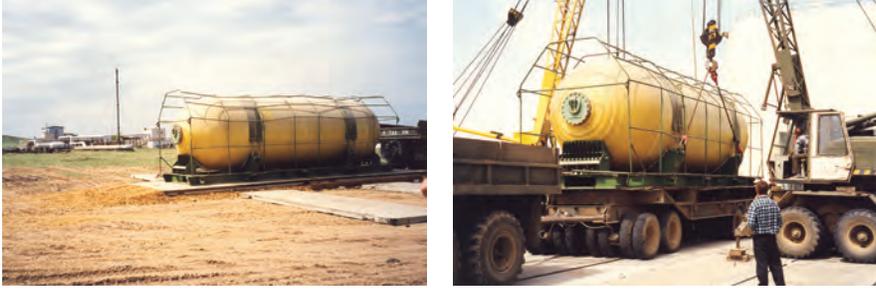
Figure 3.5. View of Kolba containment vessel at site RBSH

A reinforced concrete *settling basin* structure, banded in earth, located about 90 km from Kurchatov, within the former STS, was used as the site for the permanent shutdown of the tested Kolba containment vessels at site RBSH (Figure 3.5). The two tested Kolba containment vessels were shut down in two stages. At the first stage, the Kolba containment vessel, tested during the Kolba Explosive Attestation experiment, was shut down. At the second stage, the Kolba containment vessel currently in the *settling basin* facility was shut down.

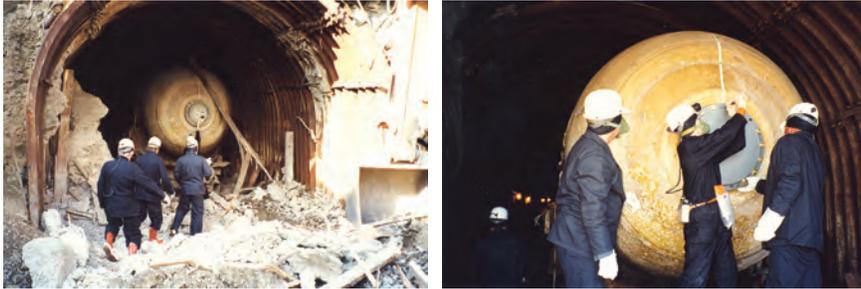
Figure 3.7. View of Kolba containment vessel at the 200ASM site

In 1998 three spent Kolba containment vessels were shut down at Tunnel No. 200ASM at Degelen Mountain, involving the hermetic sealing of the containment vessels and the formation of concrete plugs with subsequent tunnel closure with a concrete plug (*Figure 3.7*).

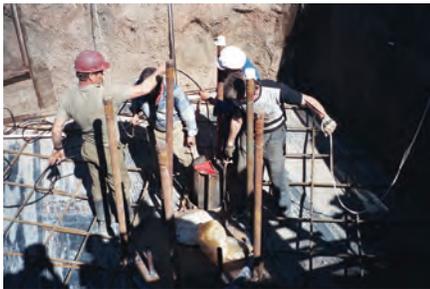
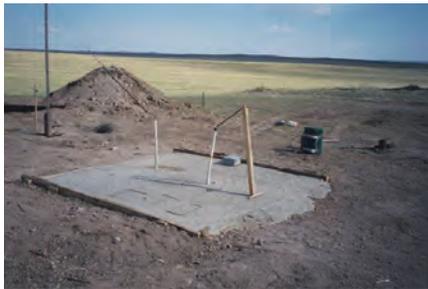
Figure 3.9. Permanent shutdown of sites 19/75 and TOP

In 1999, Russian and Kazakh specialists, working under the Agreement, rendered the special process equipment in two boreholes safe (detonating explosive charges and destroying the respective items) and shut them down (*Figure 3.9*).

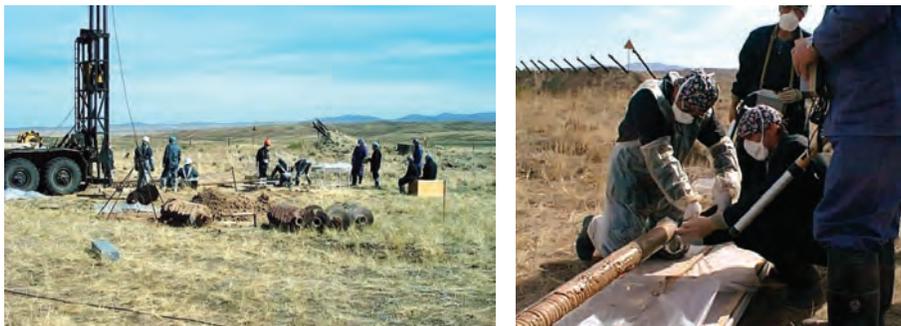
Figure 3.11. Drilling special boreholes at the Aktan-Berli Area

Stage 2. The presence of significant quantities of nuclear waste was confirmed in samples, taken from three test boreholes during the drilling of special boreholes (Figure 3.11).

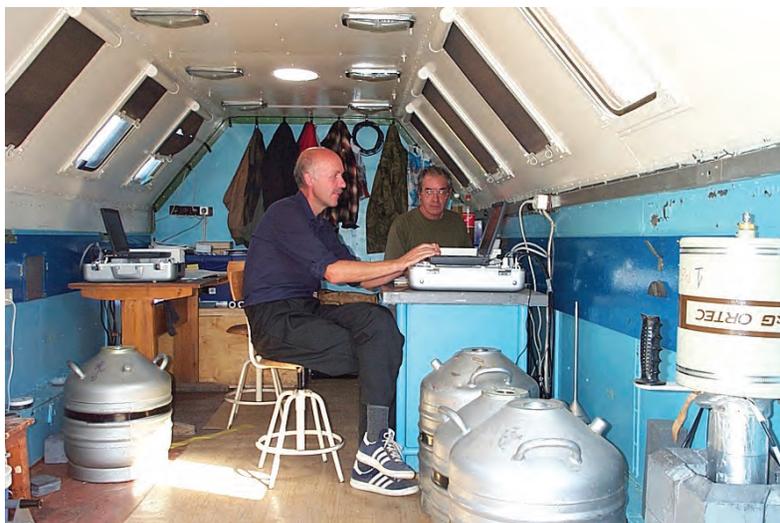
Figure 3.12. Laboratory studies

During the course of the work, the presence of nuclear waste was confirmed in a cross-section of the test boreholes in question (Figure 3.12).

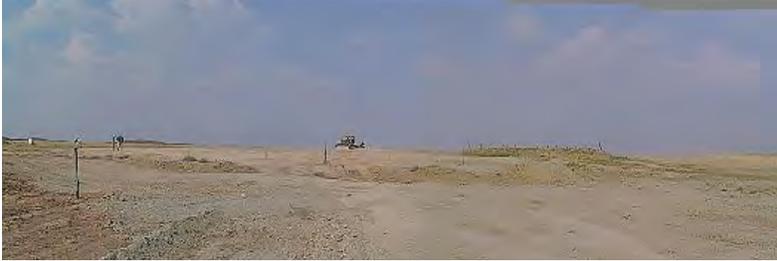
Figure 3.15. View of the work sector with backfilled contaminated zones

To reduce the impact of radioactive contamination of individual, local sectors (Figure 3.15) on personnel and the spread of radionuclides to other areas by road transport, within the confines of the protective trench, these places were backfilled with soil to a thickness of up to 0.5 metres.

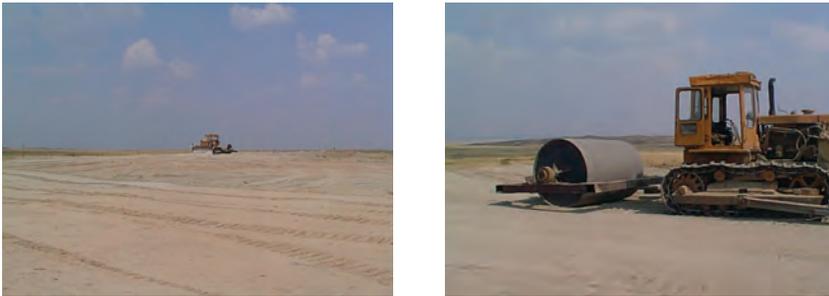
Figure 3.16. Levelling and compaction of the substructure

The preparation of the substructure involved the grading and compacting (*Figure 3.16*) of the newly delivered soil, needed for levelling the bed. The area of the mound for the substructure after soil had been added to places where it was lacking and for purposes related to the technology constituted 3,700 square metres.

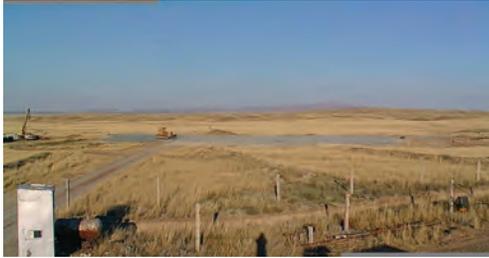
Figure 3.17. Laying the crushed aggregate into the drainage system

1,260 cubic metres of crushed aggregate in a grade measuring up to 200 mm was delivered from the region of the aggregate dump of Tunnel No. 208, to make the drainage system (*Figure 3.17*) and the base of the containment dome.

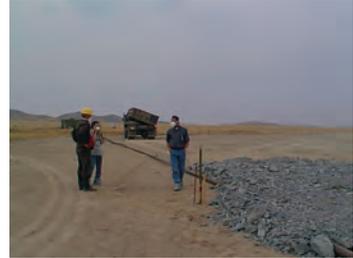
Figure 3.18. General view of the area

After completion of the drainage system installation, which simultaneously served as a cushion for laying the structure's slabs (*Figure 3.18*), a post-construction planimetric and elevational geodetic survey was conducted of the area.

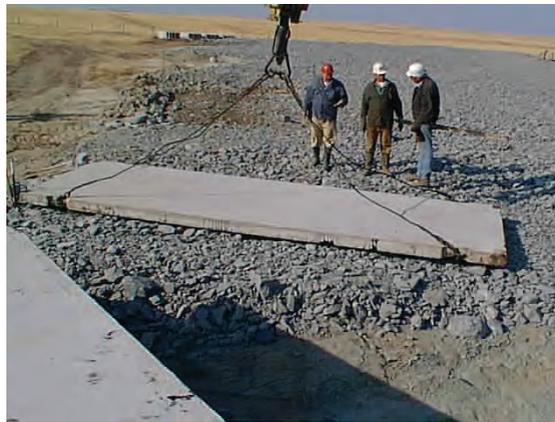
Figure 3.19. Roadway slabs

Laying the slabs. Roadway slabs (*Figure 3.19*) were manufactured at the production association Semipalatinsk Reinforced Concrete LLP in Semipalatinsk. The slabs measured 6 x 2 x 0.14 metres. Each slab had an area of 12 m², a volume of 1.68 m³ and weighed 4,200 kg. One slab used an average of 1.67 m³ of concrete.

A total of 279 12 m² slabs were used in one row; 4 rows making a total of 1,116 slabs, to cover an area of 3,348 m².

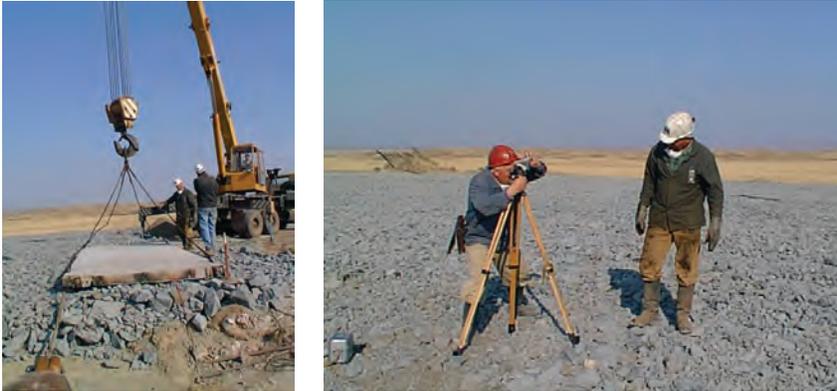
Figure 3.20. Laying the first row of slabs

The slabs were delivered on a trailer from the temporary storage area to the place they were laid and put in place using a truck-mounted crane. The first row of slabs was laid on the substructure, aligned with the survey tool. The substructure was graded by filling in fine gravel using a loader (*Figure 3.20*).

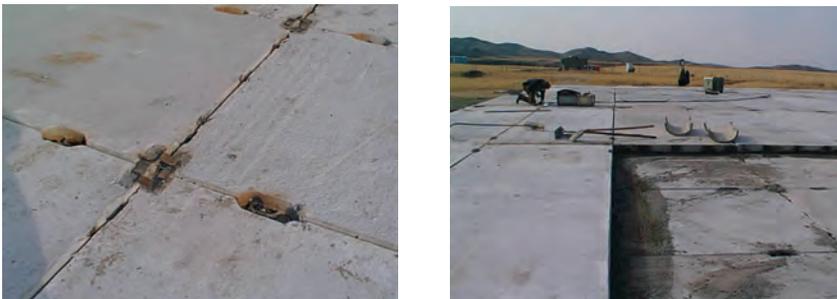
Figure 3.21. Joining slabs in a row

The slabs were joined in each row using arc welding to specially embedded inserts (8 inserts per slab) and between the lifting loops, located on the corners and sides of the slabs (*Figure 3.21*).

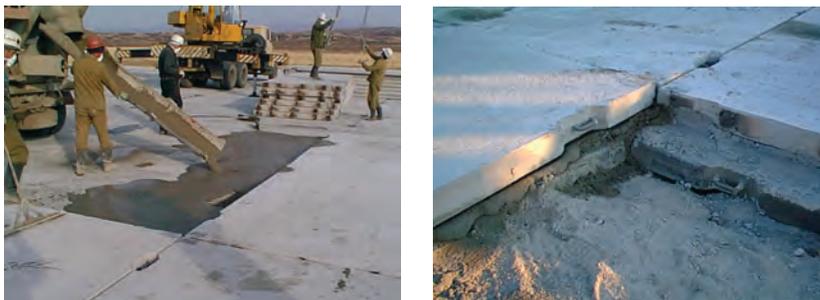
Figure 3.22. Laying fine-aggregate concrete between rows of slabs

The rows of slabs were connected together using fine-aggregate concrete up to 20 mm thick all over the area of the row. When laying the mortar between the rows of slabs (*Figure 3.22*), the entire space between the slabs of the previous row was filled with this same mortar.

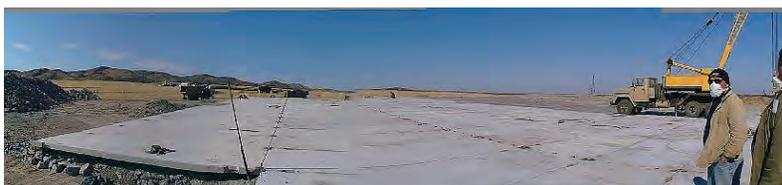
Figure 3.23. View of the second row of slabs

An overview of the construction after laying 2 rows is presented in *Figure 3.23*.

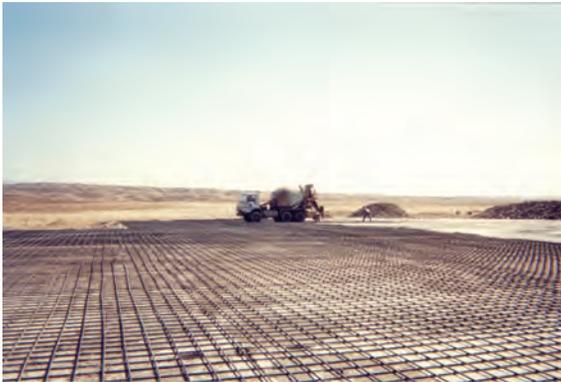
Figure 3.26. Reinforcement metal mesh and laying concrete in the cement screed

To ensure the work was completed on schedule and given the current circumstances (a lack of slabs for laying the fourth row, favourable weather conditions), simultaneously with the laying of slabs and installation of connecting members, the reinforcement metal mesh was assembled and the concrete of the cement screed was laid (*Figure 3.26*).

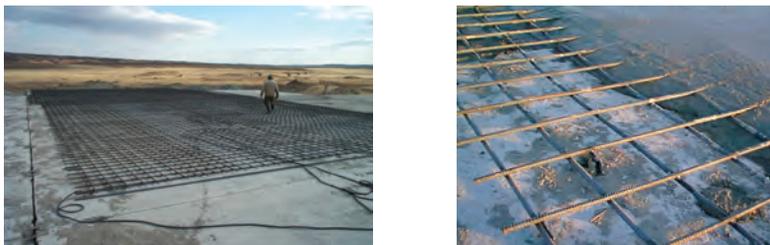
Figure 3.27. Laying the reinforcement metal mesh

The reinforcement meshes were made on site, meaning on the upper row of the slabs (*Figure 3.27*). The reinforcement metal of the cement screed was arc welded to the reinforcement metal connecting members of the superstructure.

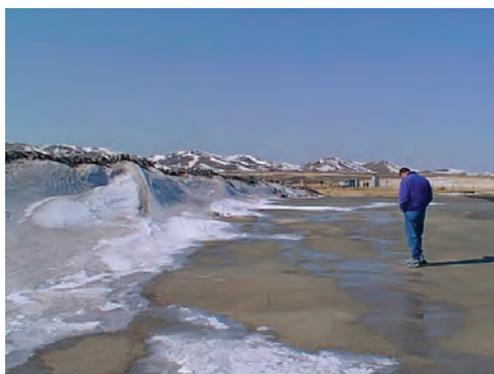
Figure 3.28. Inspection of the screed condition

Before the concrete pouring work was allowed to continue, a DCMA representative inspected and accepted the previously completed screed (*Figure 3.28*).

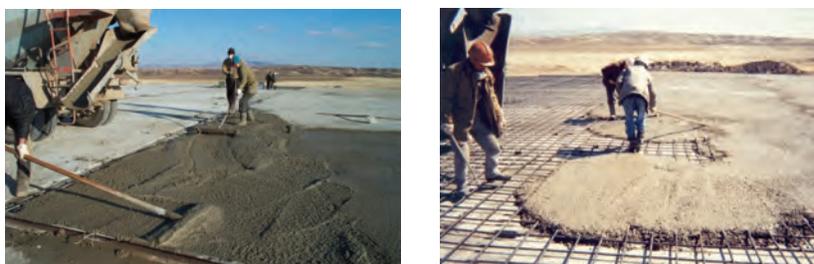
Figure 3.29. Laying the concrete

The ready-mix concrete for this element of the containment dome structure was laid in a horizontal layer up to 10 cm thick (*Figure 3.29*).

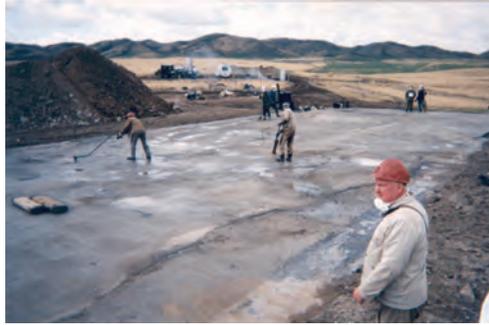
Figure 3.30. Preparing the section for laying bitumen felt

Laying bitumen felt. Work began from 12 April 2003 on covering the cement screed with two layers of bitumen felt. This work proceeded at the same time as the cement screed was being applied (*Figure 3.30*).

The bitumen felt was laid at any air temperature (*Figure 3.30*) but only at times of no atmospheric precipitation.

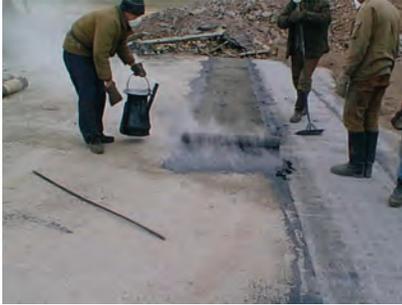
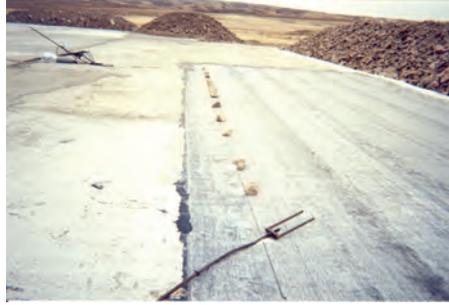
Figure 3.31. Laying bitumen felt

The surface of the cement screed was first primed with a bitumen solution and then the 2 layers of RKM-350B bitumen felt were applied (*Figure 3.31*).

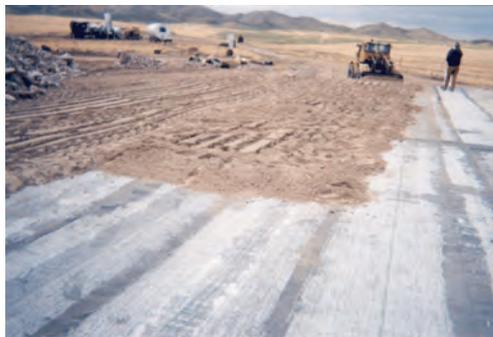
Figure 3.32. Protective sand layer

20 mm. The purpose of this was to protect the felt from tearing when building up the earth mound from macrofragmental soil (*Figure 3.32*).

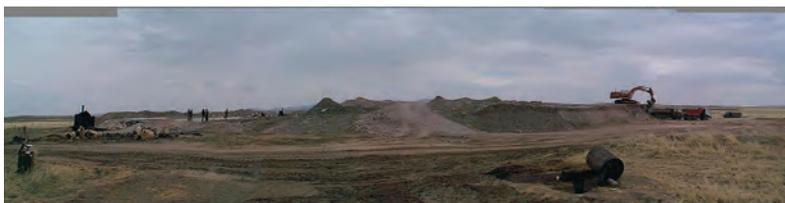
Figure 3.33. Overview of earth mound construction

The soil from the temporary store was loaded by digger into trucks and delivered to the containment dome (*Figure 3.33*). The earth mound was built up over the erected containment dome to the rated elevation points with the earth spread in layers by bulldozer. The soil was compacted by the trucks and bulldozer as it was laid and levelled.

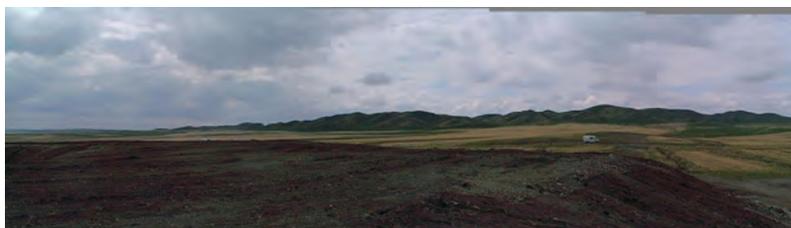
Figure 3.34. Surface of the earth mound

The angle of slope of the dumped earth, going beyond the limits of the borehole field, varied from 18 to 42°. The surface of the earth mound was levelled and backfilled with fertile soil (*Figure 3.34*).

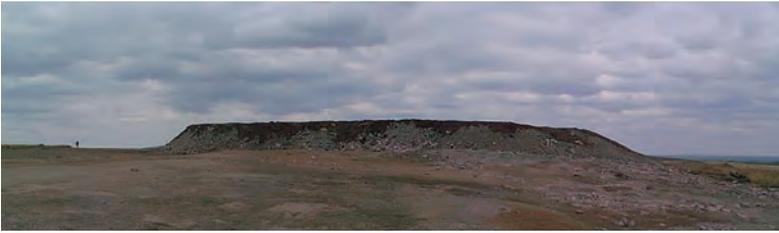
Figure 3.36. View of the structure from the south

The general view of the earth mound, covering the reinforced concrete containment dome, is presented in *figures 3.35 and 3.36*.

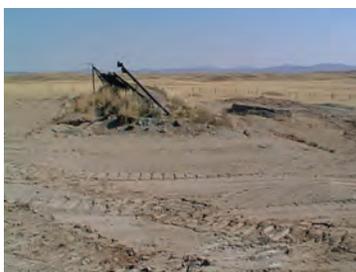
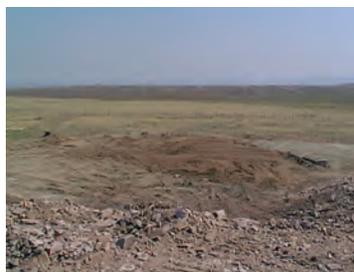
Figure 3.38. View of the site of the protective cover, before and after reclamation

Reclamation of the sector. During the course of the reclamation, some of the site's tell-tale signs (*Figure 3.38*) were removed, the soil from which was laid in the earth mound.

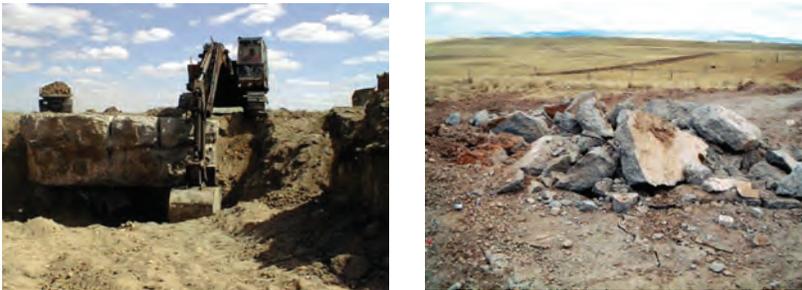
Figure 3.45. Destruction of concrete plug on borehole No. 1

Destruction of concrete plugs on the boreholes. Preliminary work was performed on boreholes 1 and 2 to destroy concrete plugs measuring 4 x 4 x 2.4 metres, with the subsequent digging of the foundation pits. The concrete plug at the head of borehole No. 1 was destroyed using a 40 kg blast of chemical explosive (*Figure 3.45*).

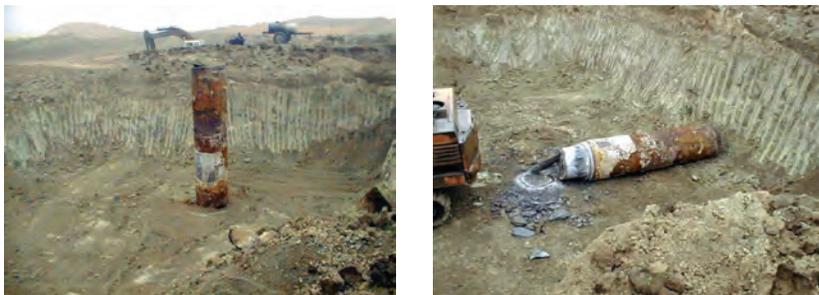
Figure 3.46. Removal of borehole casing

Cutting and removal of the borehole casing. At the end of the earth-moving operations in each foundation pit, at the elevation point of -5.5 metres, the drill casing of the test boreholes with concrete in the annular space was undercut and temporarily removed from the foundation pit to the surface (Figure 3.46).

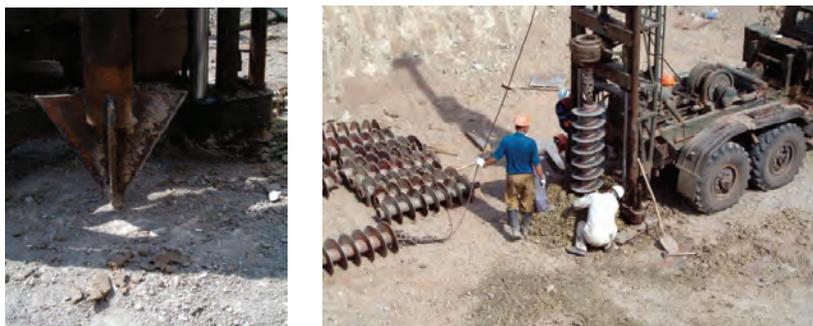
Figure 3.50. Drilling special boreholes

each borehole and to their spudding-in. The spudding-in (driving the upper part of the borehole to set the necessary drilling angle) was performed using a special pitching borer, a bit in the form of a feather (*Figure 3.50*).

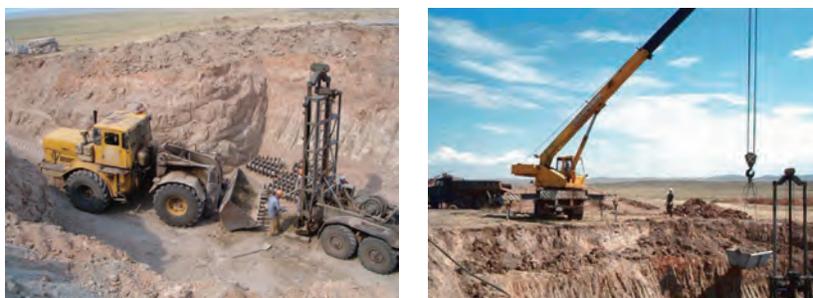
Figure 3.51. Removal of soil from the foundation pit

After drilling, the boreholes have to be filled with mortar. In light of this and also given the limited dimensions of the substructure of the foundation pit, the soil extracted from the boreholes was stored on the sides of the foundation pits. The soil was removed from the foundation pit using a loader or truck-mounted crane with bucket (*Figure 3.51*).

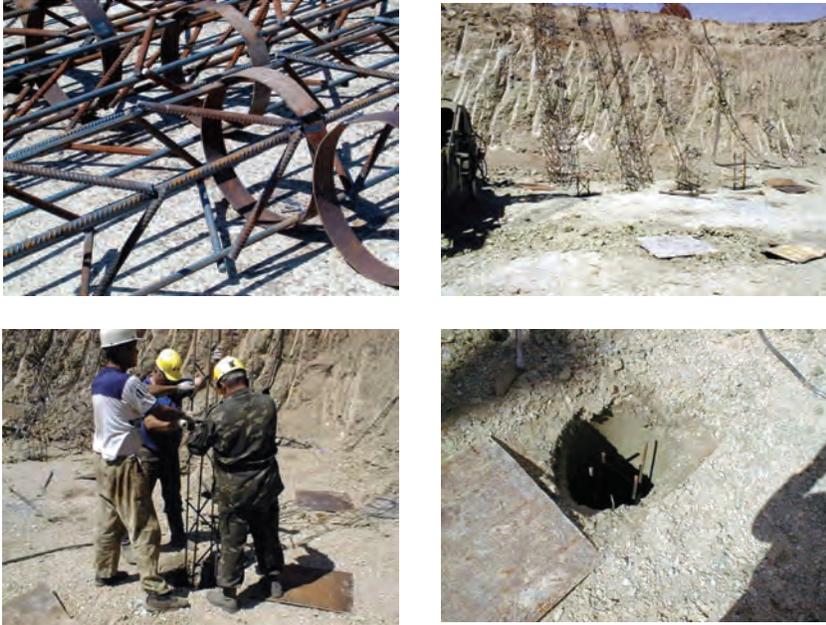
Figure 3.52. Manufacture and installation of reinforcement mesh

The elements of the reinforcement meshes were delivered to the foundation pits. Using a truck-mounted crane, mesh sections up to 10 metres long were lowered into the borehole and connected with one another by arc welding (*Figure 3.52*).

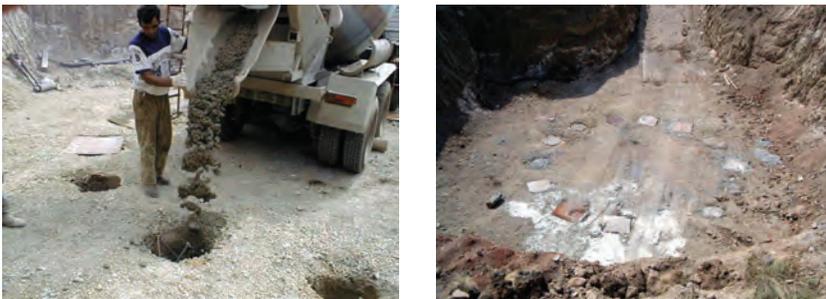
Figure 3.53. Concrete casing of boreholes

Casing of boreholes. Once the reinforcement was fitted, the boreholes were cased in mortar with compaction. The concrete was fed from a mixer directly into the borehole along a conveying culvert (*Figure 3.53*).

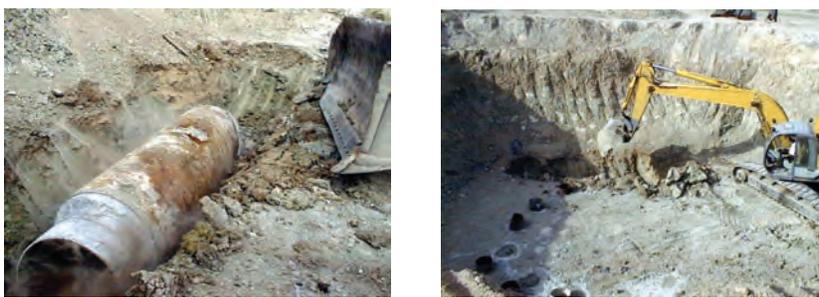
Figure 3.54. Burial of borehole casing in the foundation pit

Within the substructure of the containment dome for type-1 boreholes, measuring 10 x 10 metres, a trench was dug up to 1.2 metres deep using a digger. The cut parts of the borehole casing were then placed into this trench, which was then backfilled with soil (*Figure 3.54*).

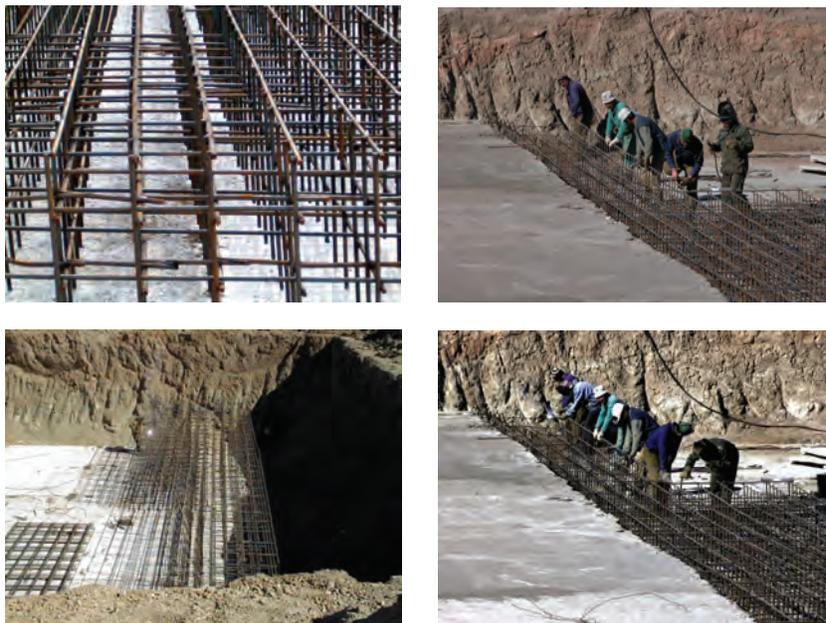
Figure 3.57. *Manufacture of the reinforcement metal mesh*

Manufacture of meshes from the elements. The elements of the reinforcement meshes were brought to the site of their installation, joined together using reinforcement

steel and secured by arc welding. The cells in the mesh measured 20 x 20 x 25 cm (*Figure 3.57*).

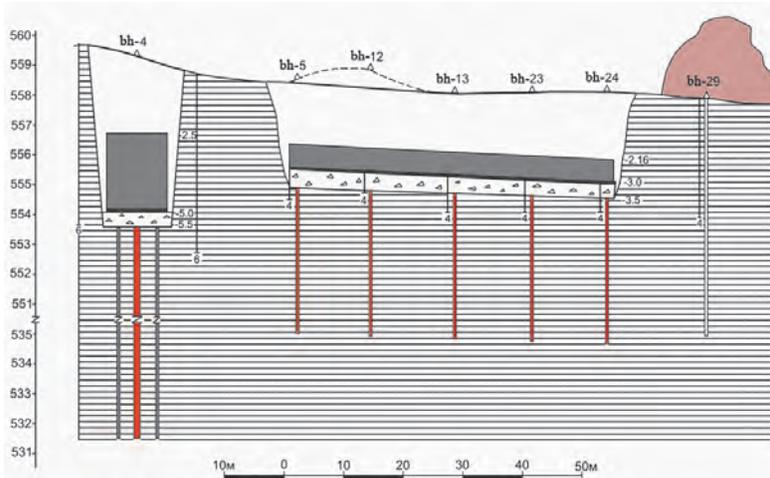
Figure 3.60. Configuration drawing of containment domes

The mean thickness of the cast-in-place part of the containment dome over type-2 boreholes is 0.69 metres; allowing for the thickness of the slab, the thickness of the reinforced concrete containment dome was 0.83 metres (*Figure 3.60*).

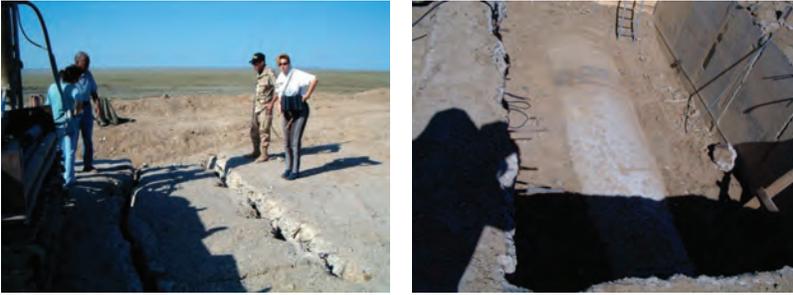
Figure 3.63. *Opening of the structure*

Stage 1. The first stage included preparation of the working area for the work to begin. The structure was opened to ensure access to the Kolba containment vessels (*Figure 3.63*).

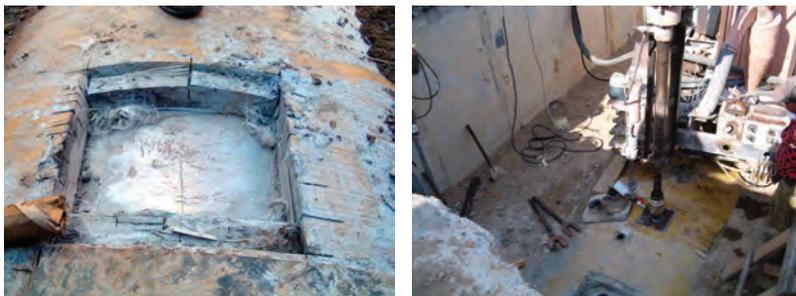
Figure 3.64. Model experiments

During the debugging of the technology (*Figure 3.64*) the following sequence of operations for filling the containment vessels was adopted, which needed to ensure the safe performance of the Statement of Work for the operation:

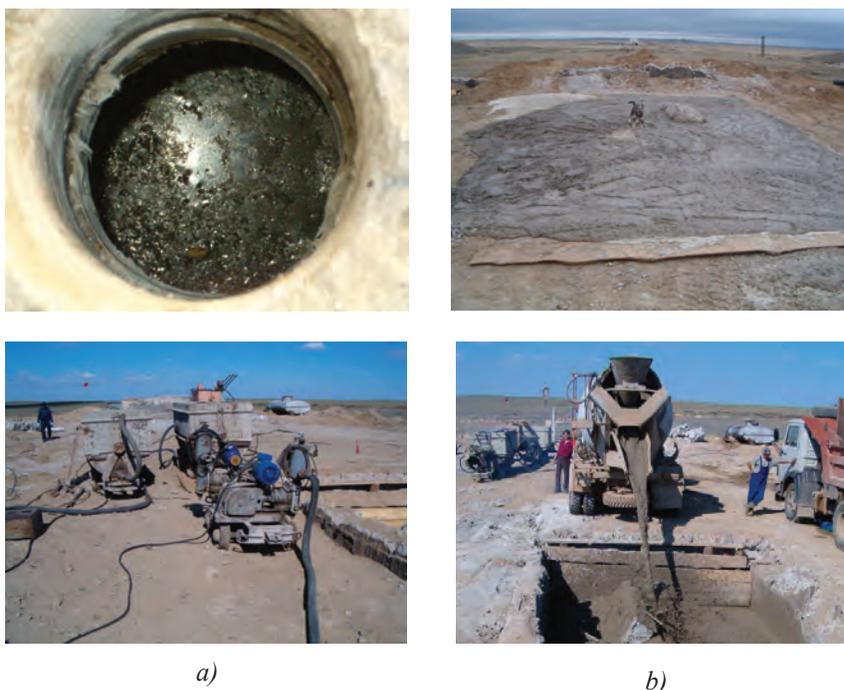
Figure 3.65. Filling the containment vessel with solution (a) and restoring the concrete cover (b)

Stage 3. Work was first performed on a *clean* containment vessel, into which 24.8 m³ of solution was pumped (*Figure 3.65, a*).

At the concluding stage, the containment vessel was placed for permanent storage into a structure and the structure was then concreted and the concrete cover was restored. The concreting was performed direct from mixers from the top of the structure. The cover of the structure was also filled with concrete to the elevation of its upper part (*Figure 3.65, b*).

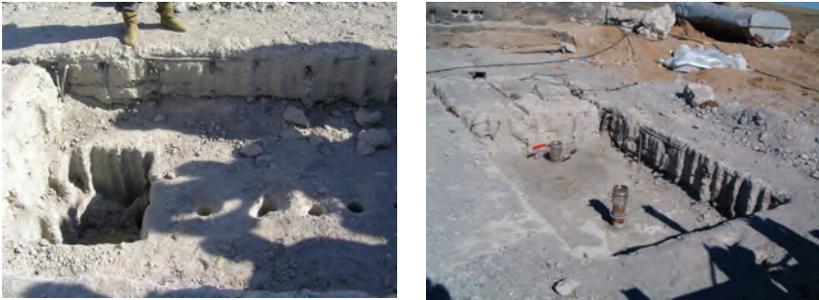
Figure 3.66. Opening of the structure's ceiling

concrete. At the other end of the sump hole, at a distance of 1.2 metres from the feed tube for borehole No. 2 (injection borehole), a feed tube was installed for borehole No. 1 (for gas blowoff). A borehole was made in the sump using a 127-mm drill bit, into which a steel tube with a 112 mm diameter was inserted. The annular space was cemented with mortar (*Figure 3.66*).

After the cement had hardened, the mortar was drilled out in the feed tube using a drill bit, 105 mm in diameter and which could not drill through the metal of the casing.

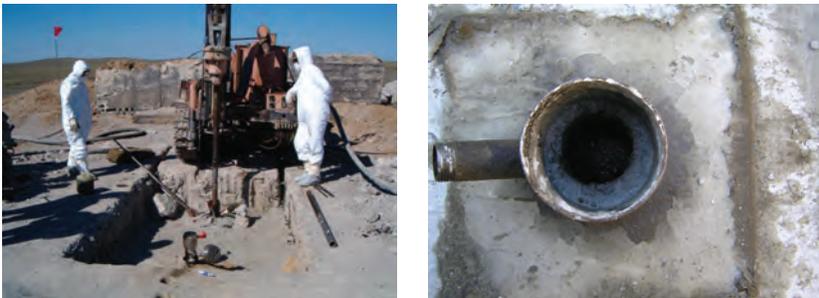
Figure 3.67. Preparation for opening the containment vessel

There was a certain degree of risk involved in the direct opening of the containment vessel. In light of this, the drilling personnel were given final instructions on what to do when opening the containment vessel, the design of the drilling assembly was perfected and tested, the assembly was stabilised with a limiter welded to the support frame, the necessary tools were prepared (wrenches, connecting nozzles and bore bit), a flag was fitted to determine the wind direction and duties were assigned among the staff (*Figure 3.67*).

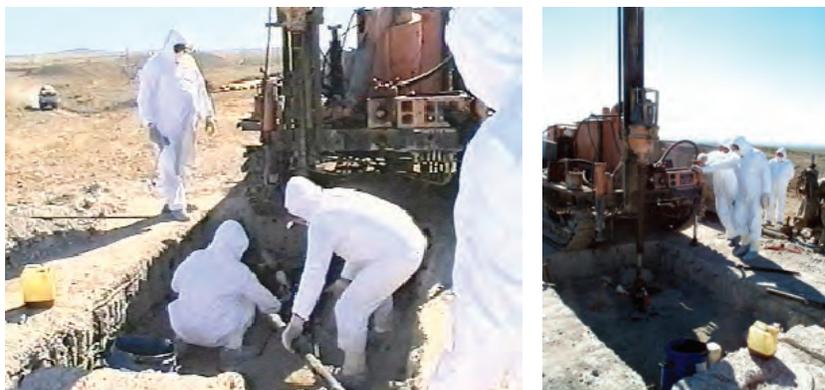
Figure 3.68. *Drilling operations*

After the drilling assembly had collapsed into the borehole up until the pre-secured limiter on the support frame of the drill unit, the core equipment was disconnected from the drill unit and thrown into the containment vessel (*Figure 3.68*).

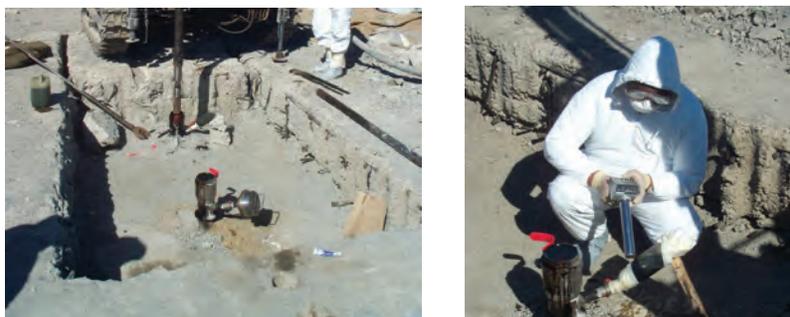
Figure 3.69. *Release of contaminated air from the containment vessel*

Contaminated air was released from the containment vessel through an oil seal. A 20 mm ball valve regulated the rate of gas release based on the quantity of bubbles that formed in the oil tank. Throughout the period of gas release from the containment vessel (90 minutes) constant radiation monitoring was performed on the state of the gases passing through the oil seal into the atmosphere around the work site. Once the release of the gas had stopped (when no more bubbles formed and all the oil had left the tank), the 20 mm ball valve was closed, the oil seal assembly was removed and the filter unit connected in its place (*Figure 3.69*).

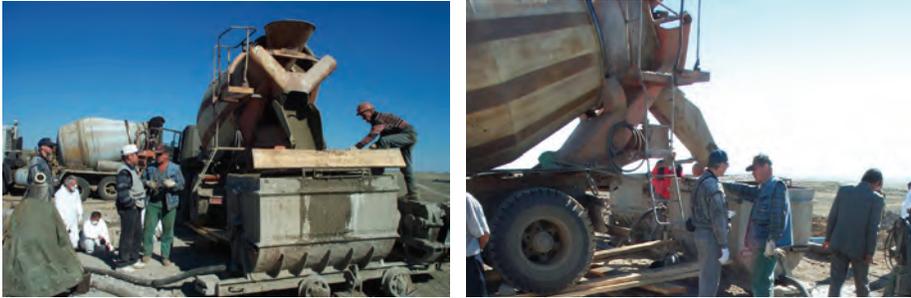
Figure 3.70. Filling the Kolba with concrete

The Kolba was filled with concrete through injection pumps, fitted on the top of the structure. A KamAZ- or KrAZ-mounted ABS-5 mixer brought the ready mix and unloaded it into the receiving tank of the injection pump (*Figure 3.70*).

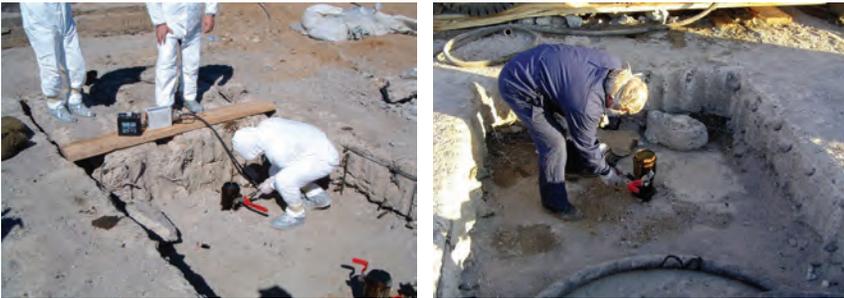
Figure 3.71. Monitoring the state of the gaseous environment and replacement of the filter element

During the filling of the containment vessel with the sand-cement solution, specialists from VNIIEF TANIK periodically monitored the state of the gaseous environment in the containment vessel and the replacement of the filter element (*Figure 3.71*).

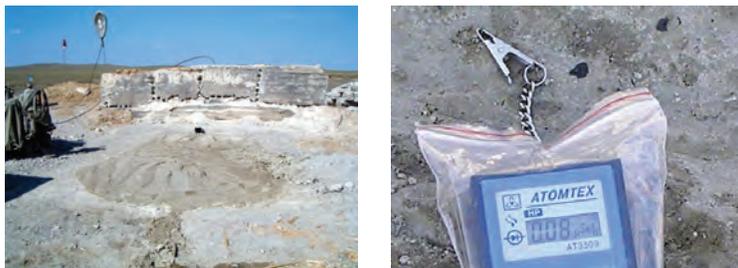
Figure 3.72. *Permanent shutdown of the containment vessel*

At the concluding stage, the opened part of the structure's ceiling was filled in to its initial level. Seals and ball valves with plugs fitted were not dismantled, but filled with concrete mortar. After completion of work on permanent shutdown of the containment vessel (filling with mortar), the exposure dose level of gamma radiation in this zone did not exceed the values of the natural background which, for this locality, stood at 0.1–0.15 $\mu\text{Sv/hr}$ (*Figure 3.72*).

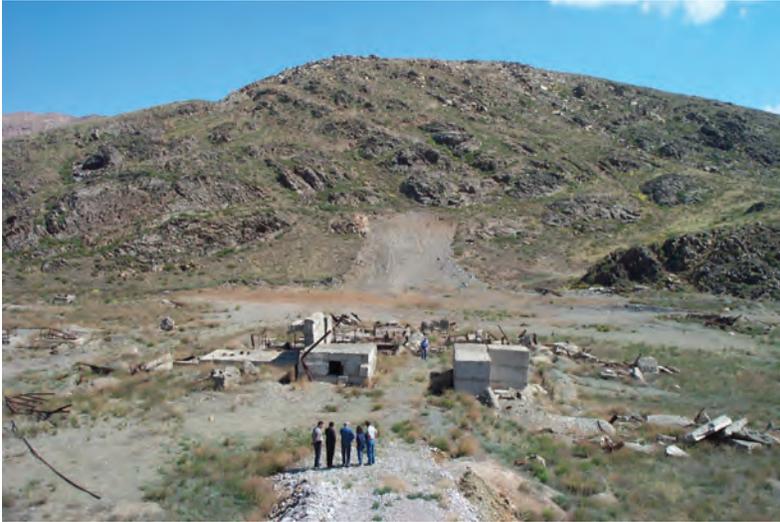
Figure 3.73. Kolba containment vessel at site K-85

Stage 4. The structure with the containment vessel, conventionally designated as K-85, is located 150 metres from the entrance to the tunnel with the same name, in the southern part of Degelen Mountain (*Figure 3.73, a*). The containment vessel, located in the structure at Area K-85, was initially shut down in 2000, when it was concreted directly in a concrete structure on ground level. An earth mound was erected over the structure (*Figure 3.73, b*).
