**SCIENTIFIC, TECHNICAL AND
ENGINEERING WORK TO ENSURE
THE SAFETY OF THE FORMER
SEMIPALATINSK TEST SITE**

Volume I

The first volume presents the results of scientific, technical and engineering work to ensure the safety of the former Semipalatinsk Test Site, also known as the *Polygon*, performed between 1994 and the present day by the National Nuclear Centre of the Republic of Kazakhstan, in collaboration with representatives of the United States of America and the Russian Federation. During the course of the work the nuclear testing infrastructure was abandoned and large-scale measures were implemented to mitigate the proliferation risks of weapons of mass destruction and prevent access to nuclear waste within the test site. The results of work on mitigating proliferation risks were given a high rating, as stated in a joint declaration by the presidents of Kazakhstan, Russia and the USA, pertaining to their collaboration at the former Semipalatinsk Test Site, made at the Nuclear Security Summit in Seoul on 27 March 2012.

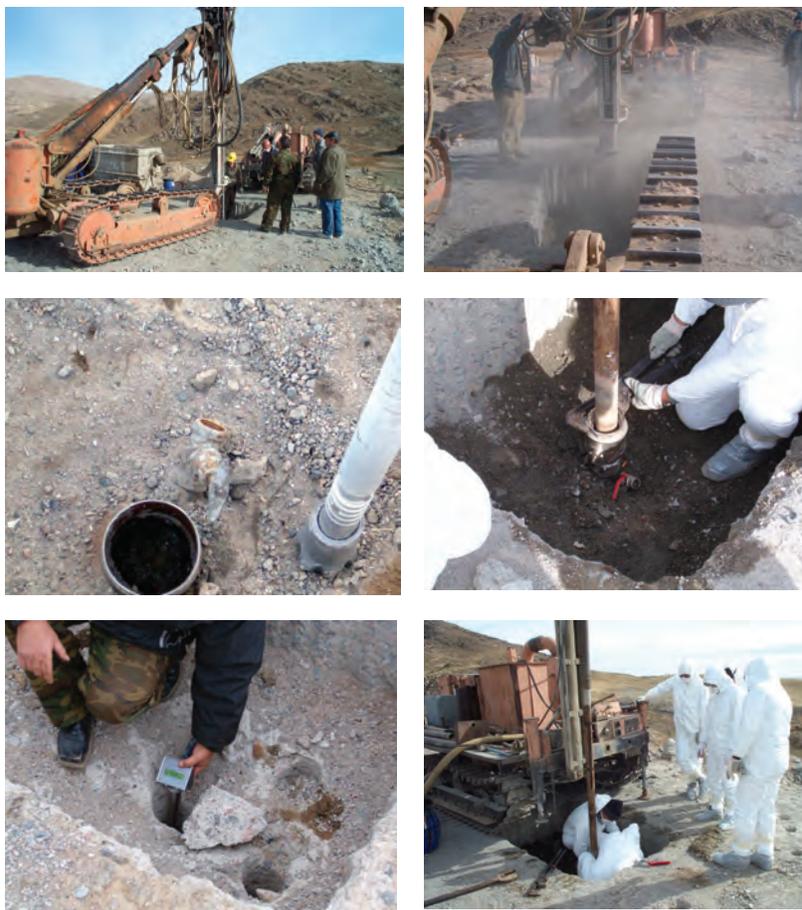
Figure 3.74. Filling the containment vessel with mortar and dosimetric monitoring

Figure 3.74 shows the process of filling the containment vessel with mortar, with dosimetric support.

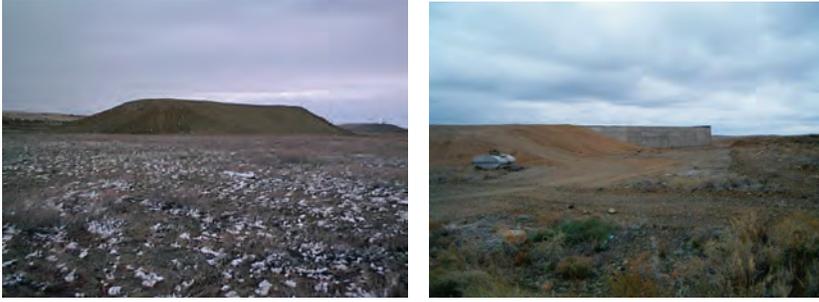
Figure 3.75. View of the structure after completion of the work

When eradicating the tell-tale signs, the adjacent structure was dismantled and the area next to the structure cleared and levelled. An earth mound was erected using a bulldozer. Soil was brought in for the mound by dump trucks from a quarry, developed earlier, some 0.5 km from the area. The earth in the quarry was readied using a digger. The earth mound stood at least 1.2 metres above the top of the structure (*Figure 3.75*).

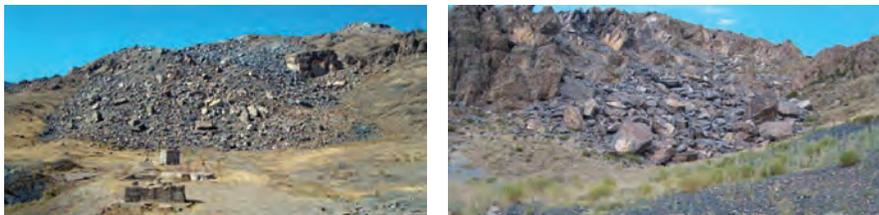
Figure 3.76. View of structures at the Nomad site

This site is comprised of two engineering structures, the left and the right. The left-hand structure contains three Kolba containment vessels. An overview of the site is shown in *Figure 3.76*.

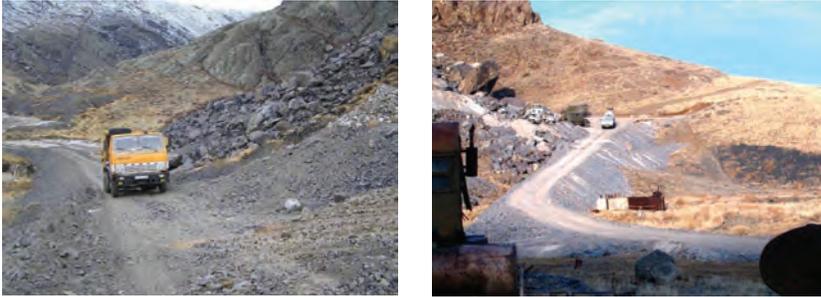
Figure 3.79. Access road

A temporary access road was built to erect the working area above the structure (Figure 3.79).

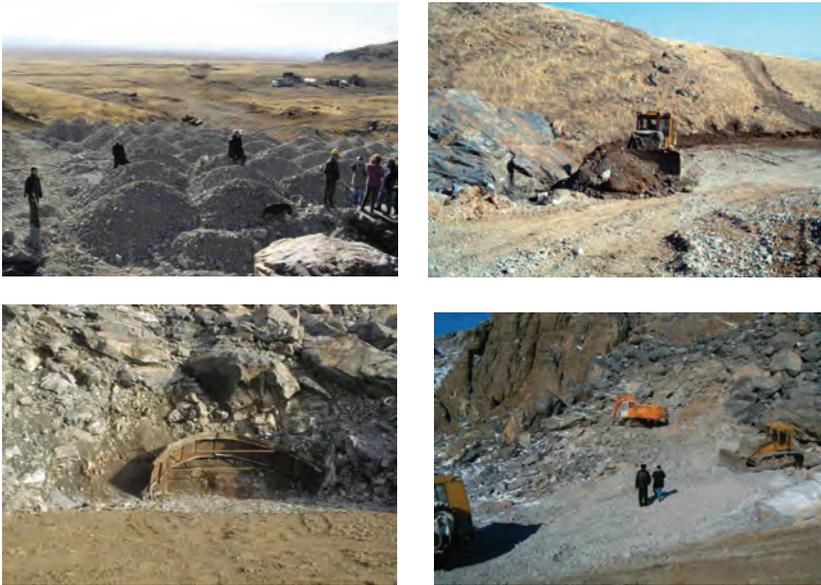
Figure 3.80. Working area over the structure

The working area consisted of two terraces, formed by crushing large fragments of rock using a number of blast cycles in blast holes and pressure charges with the

subsequent backfilling of the rock fragments with crushed aggregate from a local quarry and multiple grading of the delivered earth (*Figure 3.80*).

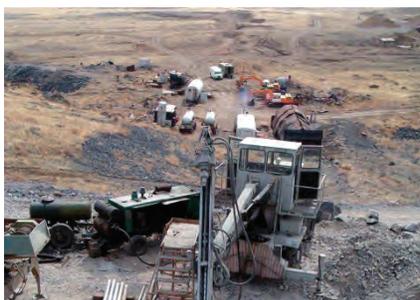
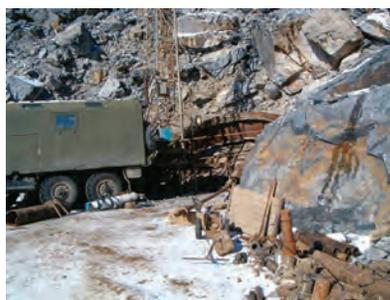
Figure 3.81. Borehole drilling

Special boreholes, with a diameter from 105 to 250 mm, were drilled from the surface of the working area. Vertical boreholes were drilled using an URB-3AM drilling rig, while inclined boreholes, with a TEJ drilling unit (*Figure 3.81*).

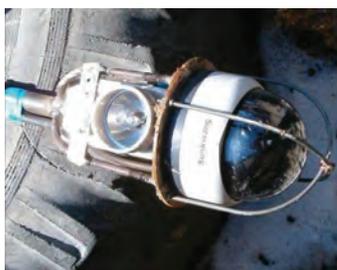
Figure 3.82. Video recording

The drilling of the first of the wildcat holes (No. 2 with a 115 mm diameter) yielded a positive result: the drilling assembly fell through into the cavity (it was the falling of the drilling assembly that determined entry into the structure). A video camera (*Figure 3.82*) helped to determine the position of the bottomhole of the first drilled borehole relative to the containment vessels. The video camera revealed that the hatch of the

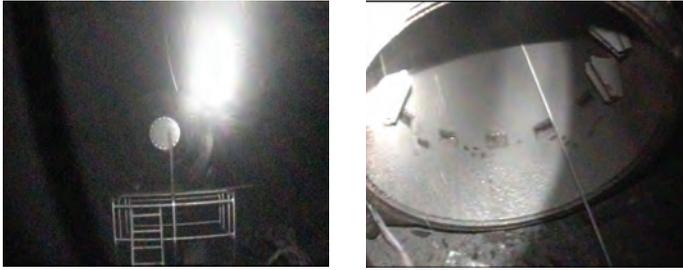
Figure 3.83. View of containment vessel No. 1 (a) and view of the sealed access point in the box (b)

Video recording in the box with containment vessel No. 1 was of a poor quality, both during the survey and when pouring in the concrete, which is linked with poor light and the absorption of the light by the walls of both the mined hole and the containment vessel (*Figure 3.83*).

The cover of the containment vessel, replaced during work in 1999, had good reflective power; the number of fixing bolts can be counted on the photographs. It was the cover that served as the starting point when surveying the box.

It was revealed that the sealed access point cover, leading out from the box, was fully open and engineering steps had to be taken to prevent the mortar from leaking into the neighbouring box.

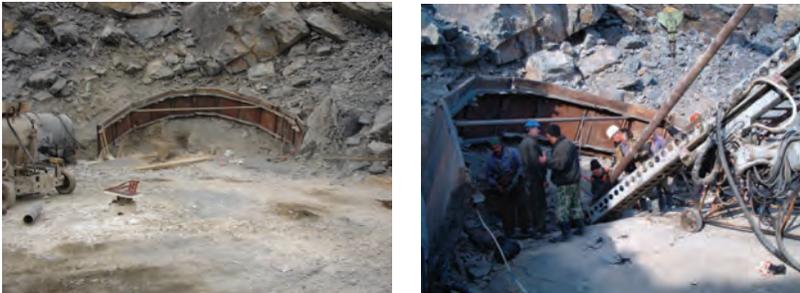
Figure 3.84. Casing the boreholes with pipes

6 special boreholes were made to pour the mortar into the box with containment vessel No. 1 and the chamber with containment vessels 2 and 3 (*figures 3.84 and 3.85*).

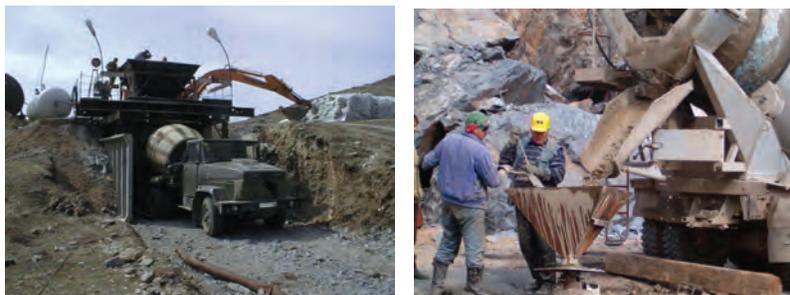
Figure 3.86. *Pouring mortar into the chamber and box*

The proportioning of the mixture for the concrete mortar was made at the concrete and mortar facility, built at the area by the left-hand structure. The mix was delivered to the working area in ABS-92 mixer trucks. The concrete was fed into the chamber directly through a special hopper, without using any pumping equipment. Once the casing string became full to the top with concrete, the process of filling the chamber was complete (Figure 3.86).

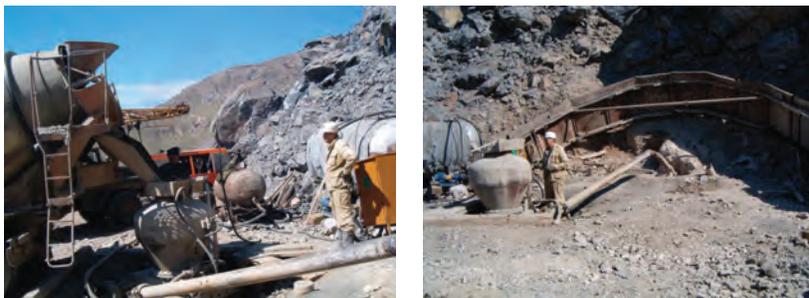
Figure 3.88. *Pouring the mortar into the box with containment vessel No. 1*

The mortar was poured into the box with containment vessel No. 1 over inclined, special boreholes 4 and 5, using a BUK-1 pump (*Figure 3.88*).

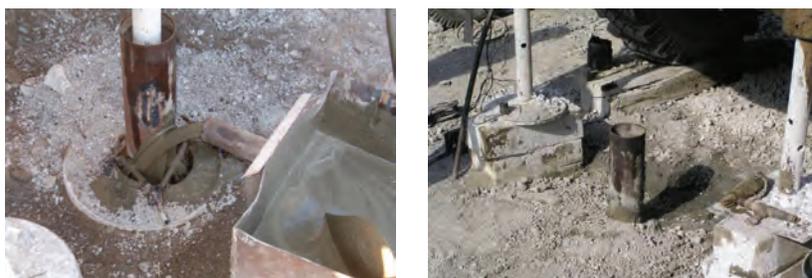
Figure 3.90. *Cementing the borehole's annular space*

The shaft of the drilled borehole was cased with steel pipes, 130 mm in diameter, after which the annular space was cemented (*Figure 3.90*).

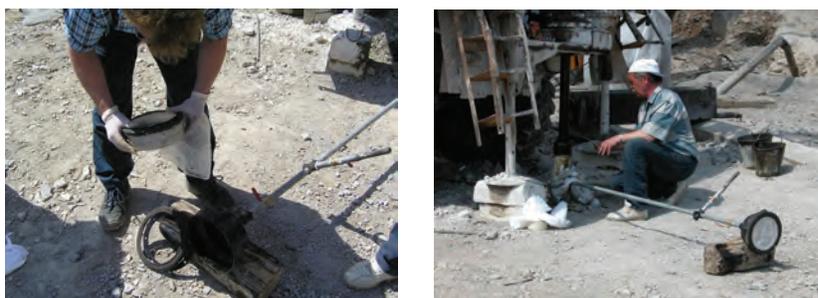
Figure 3.91. *Preparing the filtering element*

This problem was resolved using a stuffing box. A device was screwed to the casing pipe for the outlet and filtration of gases. The filtering element was manufactured in

the form of a cassette with 8 sheets of Petryanov cloth (*Figure 3.91*). The containment vessel opening operation was performed after the personnel, the equipment and appliances were ready. A hole was drilled in an oil-and-water suspension; prior to the work commencing, about 30 litres of automobile oil was poured in and then the cock opened for feeding a minimal volume of water from the tank. About 1 hour after the drilling began, the containment vessel housing was cut through. Gas flowed from the bleed system and the readings on the filter indicated the presence of radioactive contamination. Binding material was pumped into the internal volume of the containment vessel in a pressurised environment, created continuously by the column through the pumping channel and connected with the hopper. The point when the spent containment vessel had been completely filled with binding material was determined when the mix emerged from the bleed pipe.

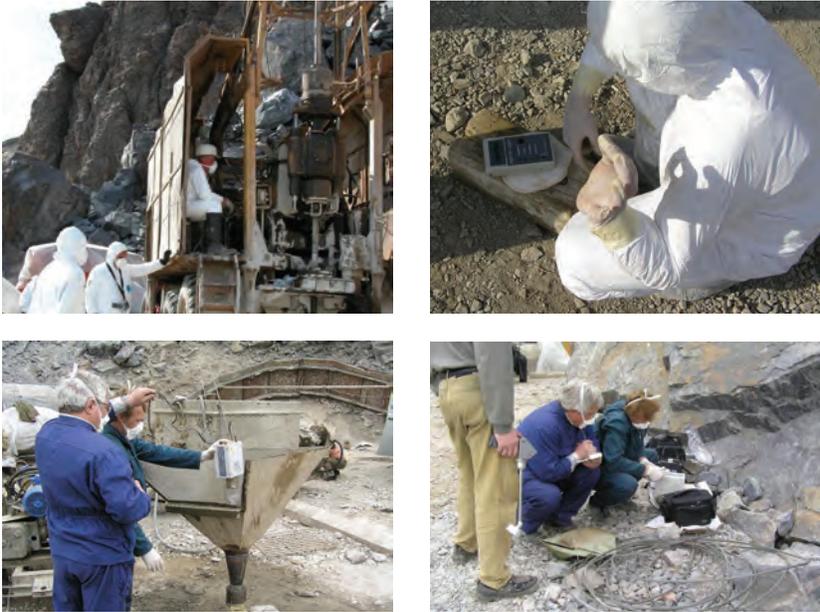
Figure 3.92. Monitoring the radiation situation after opening the containment vessel

Continuous radiation control was maintained at all stages of the work with the spent containment vessels, including with the involvement of representatives from the Russian Federation (*Figure 3.92*).

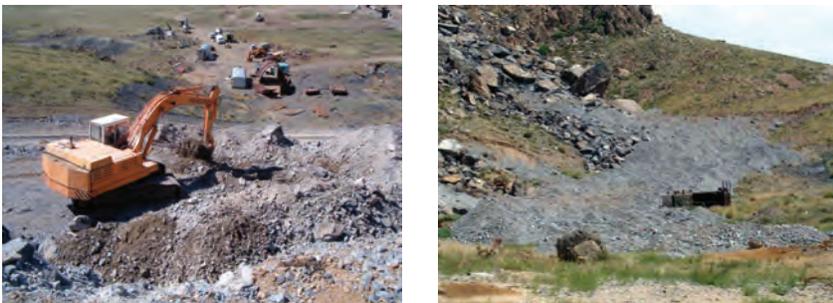
Figure 3.93. Abandoning the working area

When the work was completed, all equipment and mechanisms were removed from the working area and abandonment work commenced. Additional earth was brought in on dump trucks from the quarry and the earth, brought in earlier to construct the working area, was loosened using a digger (*Figure 3.93*).

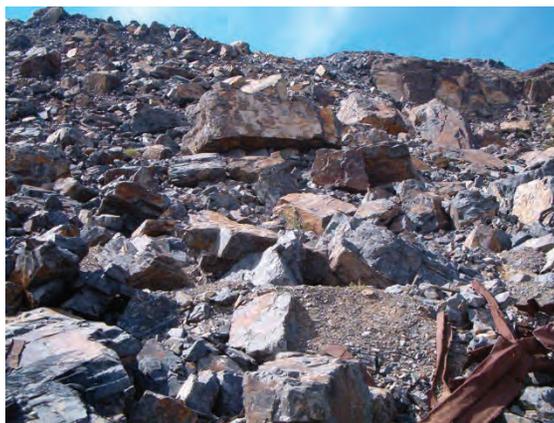
Figure 3.94. Bank of rock over the entrance to the right-hand structure

Over recent years there has been a rock slide from the upper part of the mountain, which closed off the near-mouth section of the right-hand structure (*Figure 3.94*).

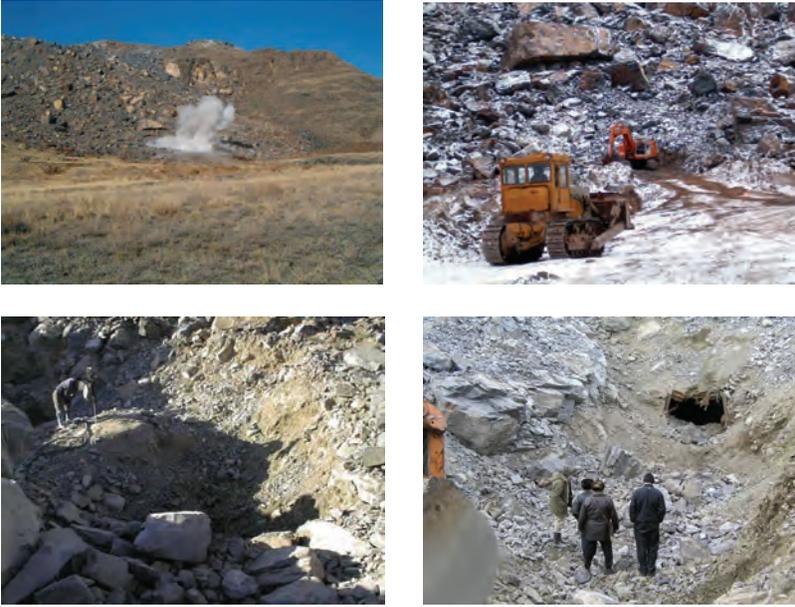
Figure 3.95. Opening of the structure

After the first frame of the structure's supports was opened up, the cut-in trench was expanded and extended (*Figure 3.95*).

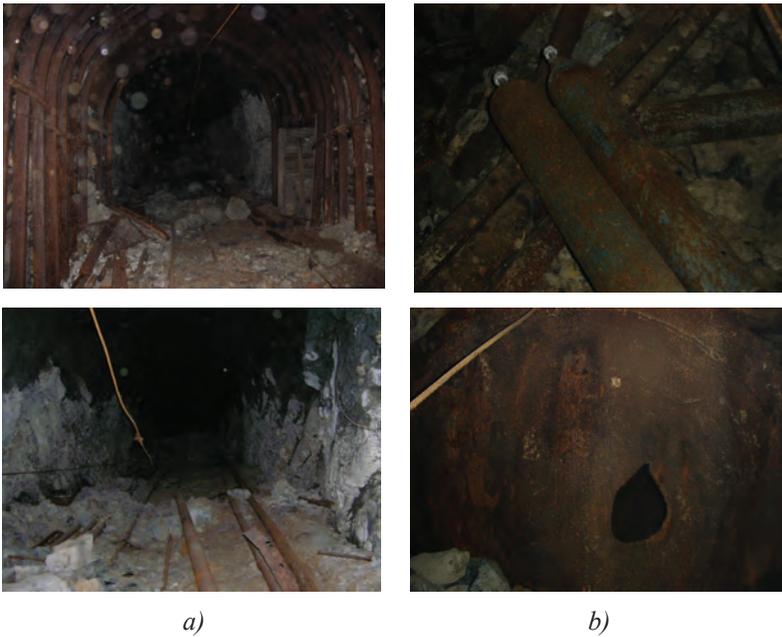
Figure 3.96. The condition of the structure (a) and traces of unauthorised activity (b)

In the presence of a dosimetrist and rescue workers, operatives from the Russian Federation and NNC conducted a preliminary survey of the technical state of the structure through the opened part of the entrance. The survey yielded satisfactory results (*Figure 3.96, a*).

At an elevation of 125 metres a concrete plug had been constructed with a welded metal pipe, 2.0 metres in diameter. Gas cylinders were found near the protective wall and a small aperture was found in the metal plate that covered the pipe, the dimensions of which made it impossible for a person to pass through. Because of this it can be

stated with confidence that there had been no unauthorised access beyond the concrete plug (Figure 3.96, b).

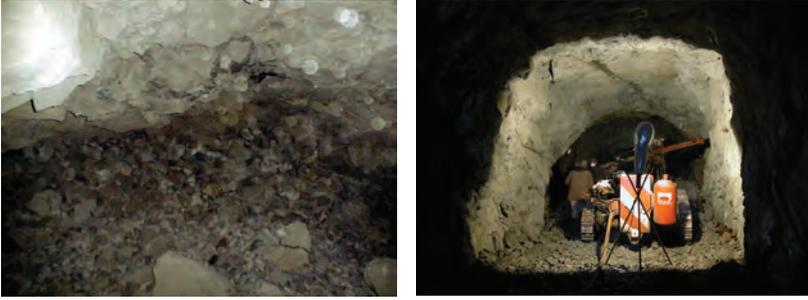
Figure 3.98. Arrangement of the caving

The earth that was collapsed when preparing the site for placing the concrete plug was shifted with a bulldozer to the site where the face of the structure was to be buried (to the survey mark at 72 metres) as a result of a blast (*Figure 3.98*).

The blast holes for collapsing the structure were drilled into the sides, cover and bottom of the excavated section using a Sullivan self-propelled unit.

When the blast holes had been drilled, the supply lines were dismantled at the collapse section, the blast holes were charged and detonated.

After the detonation the earth completely shrouded the entire section of the structure under a newly formed cover.

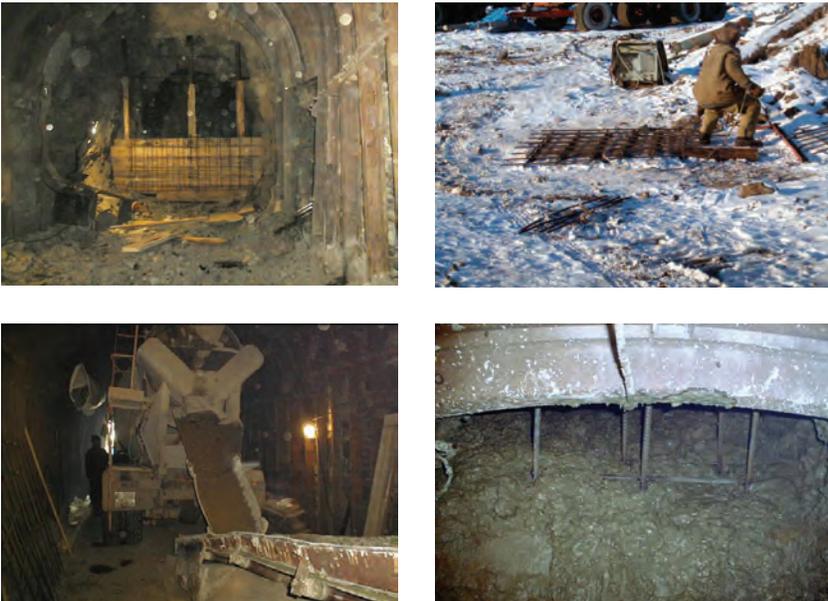
Figure 3.99. Installation of the concrete plug

The main safety element of the structure, in line with the Statement of Work, was the 10-metre long concrete plug with wedge, which is made of heavy-aggregate concrete, conforming to M300 grade (strength class B22.5).

The excavated section for the concrete element was cleared of rock debris and then wooden formwork was erected for the concrete pouring. The reinforcement meshes for housing the reinforced concrete plug were made from class A-II reinforcement rod steel with a die-rolled section with a 22-mm diameter, from grade 35GS steel (similar reinforcement steel was used in work under Operation Blackthorn).

Separate elements of the reinforcement mesh were made at the near-entrance section and then conveyed to the installation site and arc-welded to the grid. The concrete mortar was fed from a mixer truck on a conveyor and into the formwork (*Figure 3.99*).

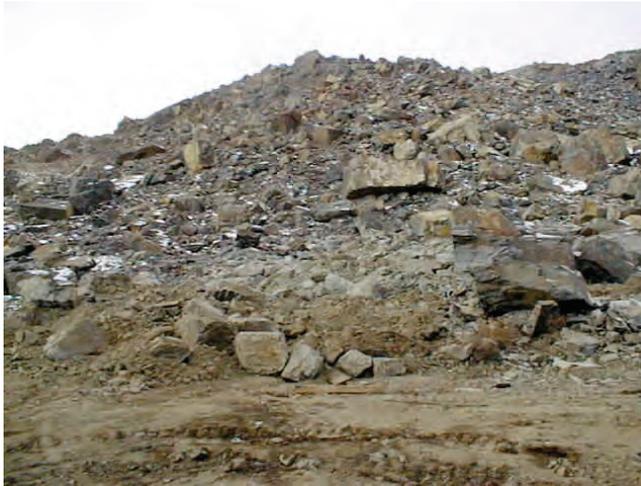
Figure 3.100. *View of the mouth after backfilling*

After installation of the concrete plug, the equipment and supply lines were dismantled, the entrance frame was taken down and the mouth of the structure was backfilled up to the existing relief of the locality (*Figure 3.100*).

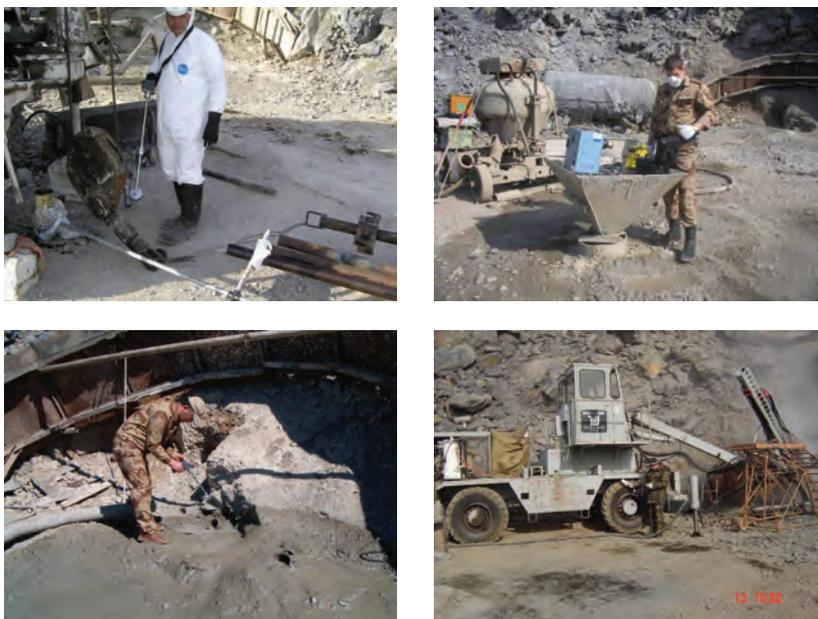
Figure 3.101. Radiation monitoring during performance of the work

Radiometric studies prior to the start of the construction work and after its completion were performed according to a single technique and observation grid; they involved measurement of exposure dose level and radiation intensity of α - and β -particles at an elevation of 0.03 metres from ground level (*Figure 3.101*).

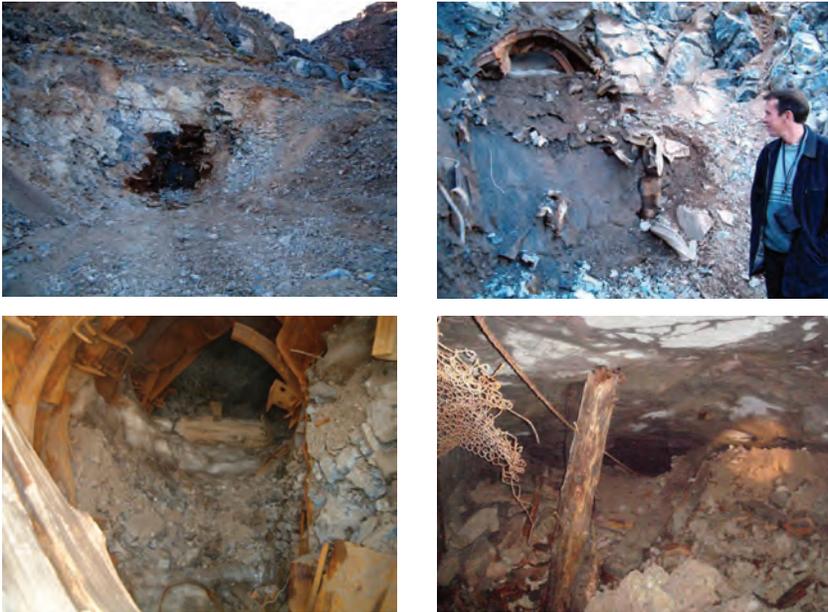
Figure 3.104. View of the structure's entrance

After dismantling the concrete safety plug, the entire section of the structure was found to be full of rock, frozen in ice. Mine rescue workers knocked a passage into the structure in the mine's upper part (Figure 3.104). Given the unsafe condition of the structure, work inside was stopped until specialists from the three countries had reached a joint decision. On 10 October 2006, specialists involved in the operation from the three countries, supported by operatives from the military mine rescue division of the Kazakh Ministry of Emergency Situations, surveyed the state of the structure to determine the possibility of and the procedure for recovery work (Figure 3.105).

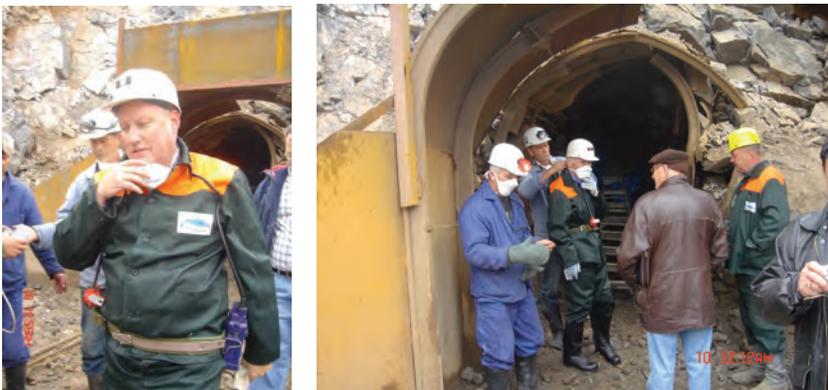
Figure 3.105. Surveying the structure at site X

- the rock mass of site X had been fragmented by preceding blasts into large blocks of rock. There were cracks on the surface of the rock mass, through which water had leached from precipitation, resulting in the bottom, the walls and the crown of the mine, at up to 30 metres to the entrance, being covered in a layer of ice;
- the right-hand side of the mine, up to 50 m in from the entrance, had been shifted 1–1.5 metres into the mine as a result of seismic activity;
- at the 50-metre point a heap of rock began, which covered the entire section of the mine;
- localised caving, up to 1.5 metres high, was detected in the ceiling of the mine.

The survey results confirmed that the structure at site X was in an unsafe condition.

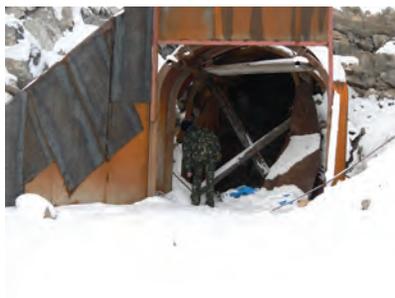
The portal to the structure at site X was provisionally sealed and placed under security (*Figure 3.106*).

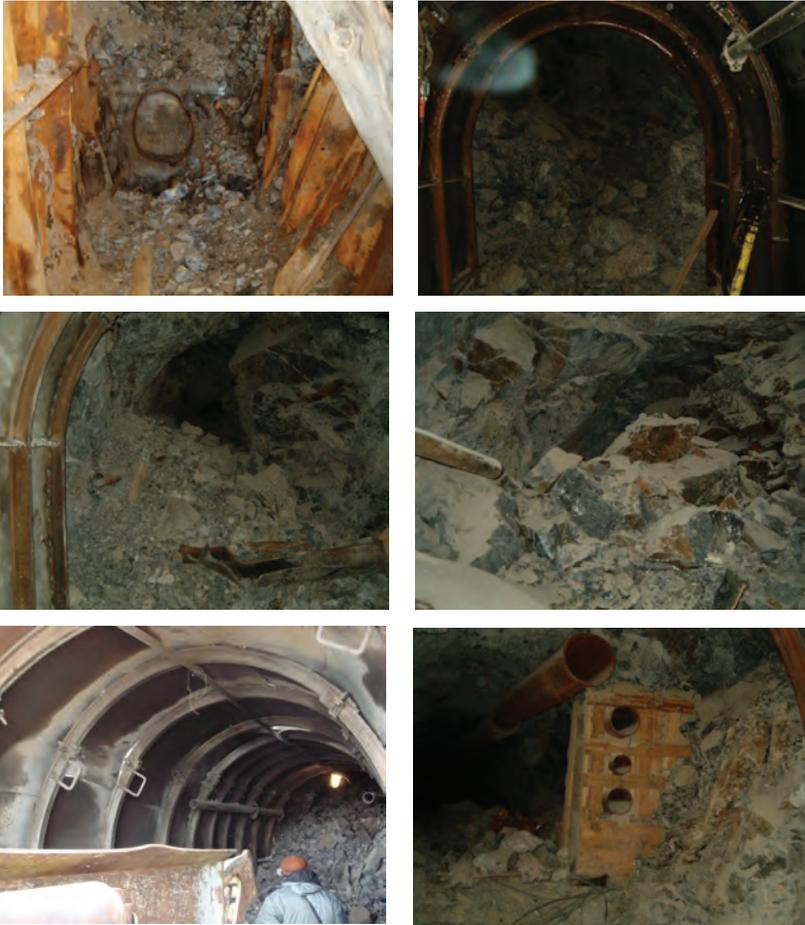
Figure 3.108. View of bottoms of separate sections

In all, from survey mark 0 to survey mark 145.5 metres in the recovered sector, 176 frames of top-drive system [SVP]-17 were installed and replaced. Views of the bottoms of a number of sections are presented below (*Figure 3.108*).

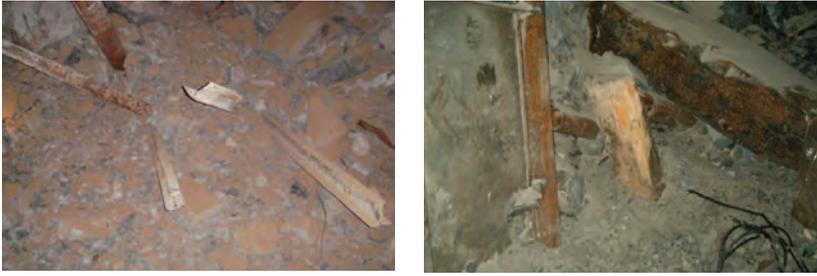
Figure 3.109. Caved rock, structures and scrap metal, to be cleared and removed

The earth is made of crushed rock, soldered together with ice as far as survey mark 50, then with building and metal structures and pipes. From the survey mark at 15 metres, the cross-section of the structure is almost 70% covered in rock, shifted from the right-hand side of the tunnel (*figures 3.109 and 3.110*).

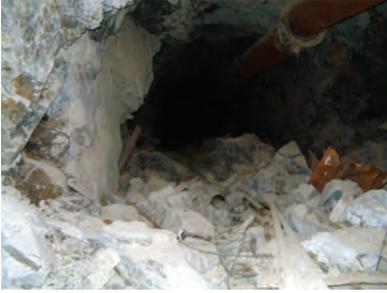
Figure 3.111. View of the sector from survey mark 110

After survey mark 110 the technical state of the mine improved. At this interval mostly caving of the rock from the ceiling of the structure was observed (*Figure 3.111*).

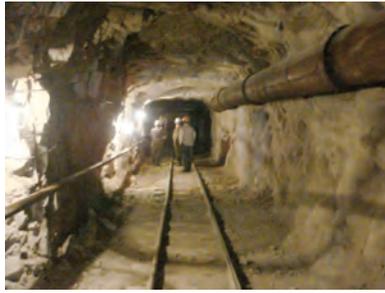
Figure 3.113. The sector to survey mark 258

The survey of the sector of the structure up to mark 258, where the penultimate plug was located, indicated that this sector was in a satisfactory technical state (*Figure 3.113*).

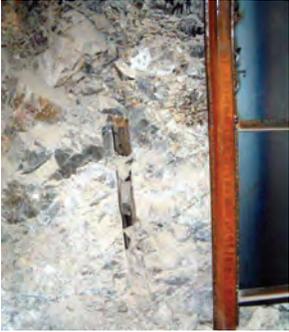
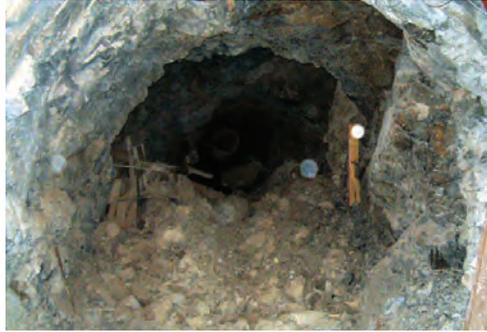
Figure 3.112. Tectonic crack on the right-hand side of the structure, with sealed access point

A tectonic fault was recorded at survey mark 111, which was traced from almost the entrance to the structure. Along the left-hand side of the structure, a slip plane was clear to see, while along the right-hand side there was a vertical crack over 10 cm wide. After repairs to the supports in the intervals between survey marks 129 and 139, the concrete protective plug was broken to 1.5 metres thick with a sealed access point at survey mark 145.5 (*Figure 3.112*).

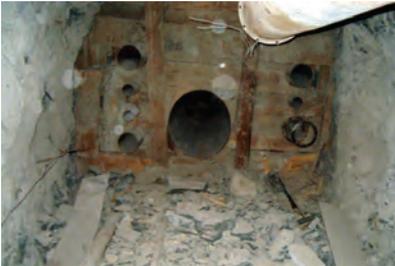
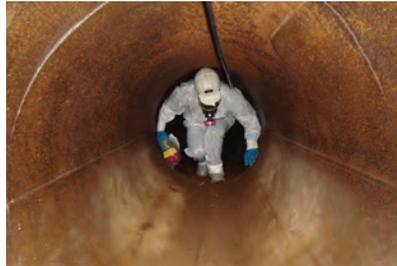
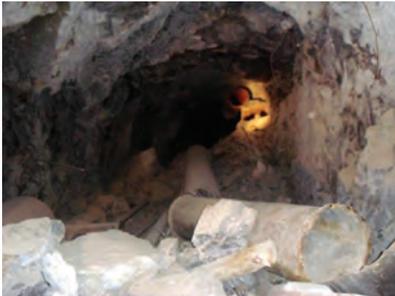
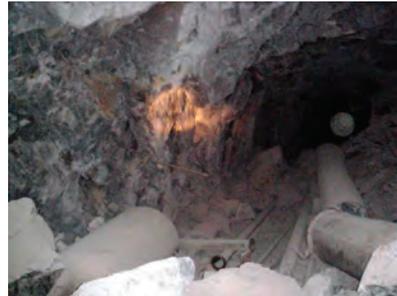
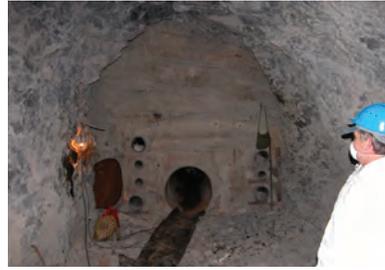
Figure 3.114. *Survey of the structure*

The concrete plug at the mark at 258 metres had a sealed access point – a metal pipe about 1.0 metre in diameter, through which a passage had been made to the box with the remnants of the special process equipment (*Figure 3.114*).

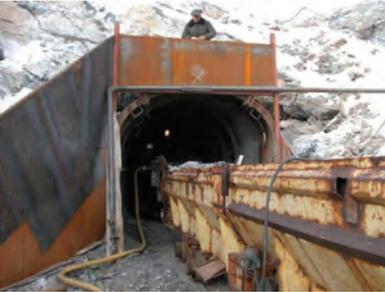
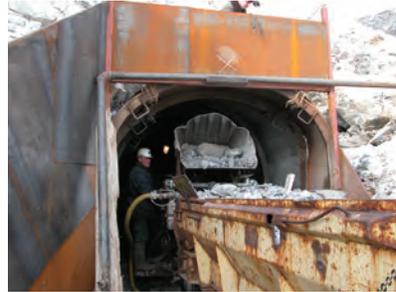
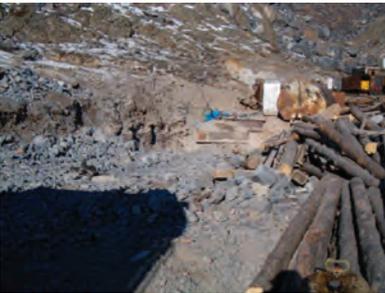
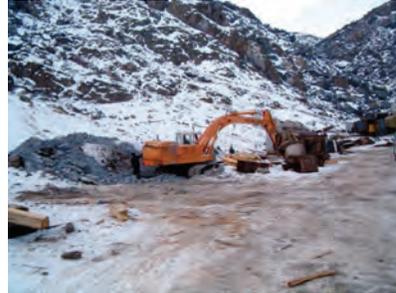
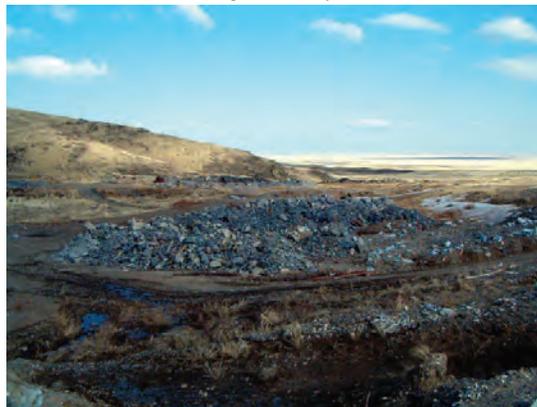
Figure 3.115. *Extraction of rock from the structure*

After the survey a decision was made about the possibility of extracting material from the box without destroying the concrete protective plug. All the rock from the structure was taken out to a storage site away from the working area (*Figure 3.115*).

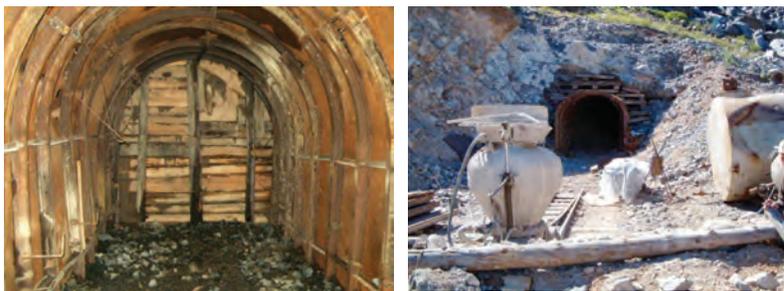
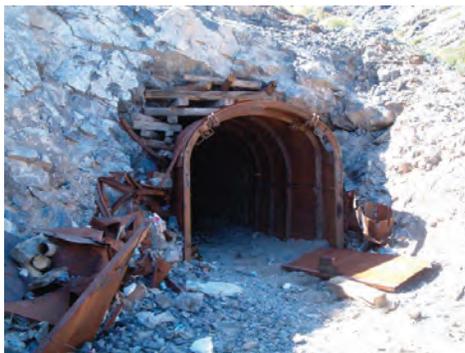
Figure 3.118. Work on the structure

In an interval of 30–40 metres, two sets of wooden formwork were installed, between which a reinforcement mesh was installed through the entire volume. Using the BUK-1's pump, installed at the entrance to the structure, 98 m³ of mortar was pumped into the plug. After construction of the concrete plug the support frame of top-drive system [SVP]-17 was dismantled in the interval of 0 to 10 metres and the structure's entrance was disassembled (*Figure 3.118*).

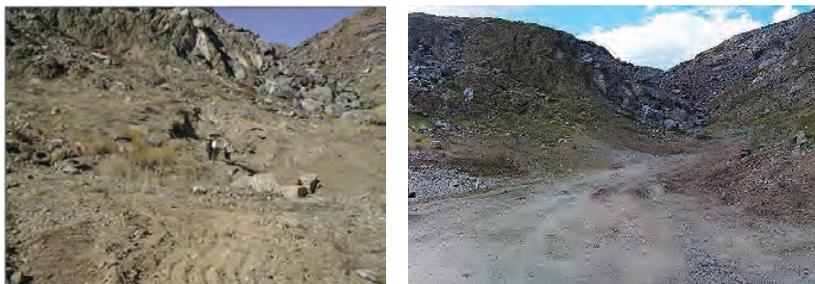
Figure 3.119. Photograph of the near-entrance area before and after the work

and the explosives storage facility was abandoned. The cut-in trench and the mouth of the tunnel were backfilled with rock and the near-entrance area and the adjacent territory were levelled using a bulldozer (*Figure 3.119*). *Figure 3.120* shows the diagram of the structure after the work was completed.

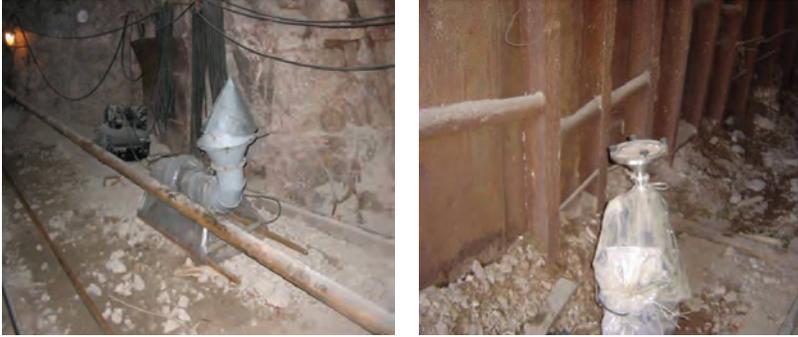
Figure 3.121. Air sampling

During the work no excess was recorded in the permissible volume activity for ^{220}Rn . Figure 3.121 displays air sampling at the work site.

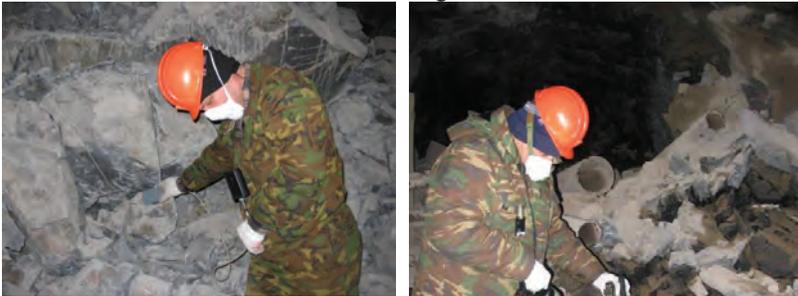
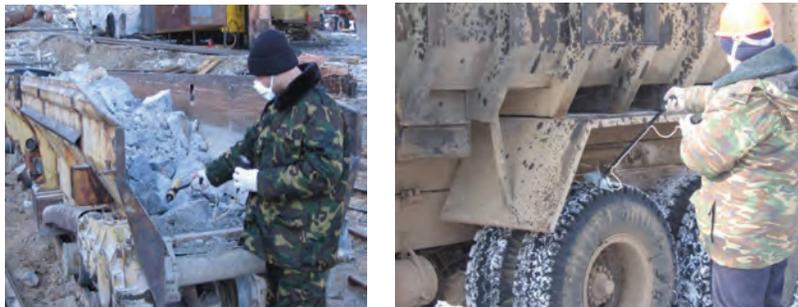
Figure 3.122. Measurement of radiation parameters

Measurement of radiation parameters included measurement of exposure dose level, the flux density of α - and β -particles of the work sites, facilities and equipment during a working shift (Figure 3.122).

When performing radiometric surveys, the measured flux density values of α -particles did not exceed the detection limit of the instrumentation used (1 particle/(min x cm²)). The measured flux density values of β -particles at all survey sites likewise did not exceed the detection limit of the instrumentation used (10 particles/(min x cm²)).

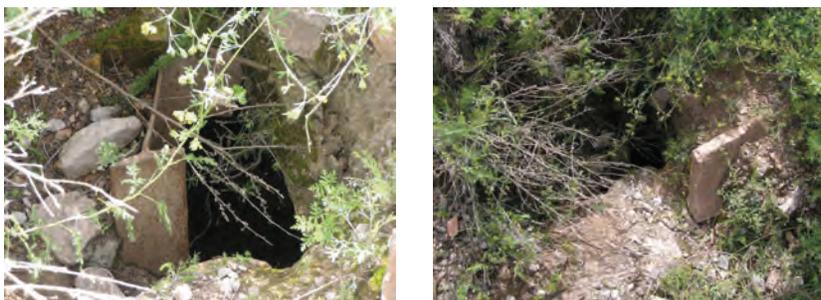
Figure 3.128. Access hole into site Y

The first sector was near the backfilling of site Y, where diggers made an access hole when attempting to penetrate the cavity of the structure (*Figure 3.128*).

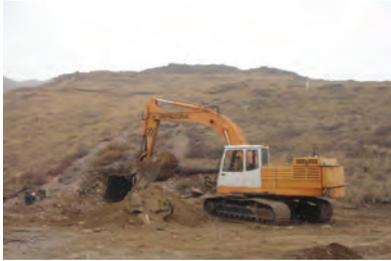
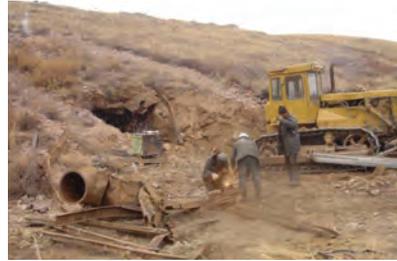
Figure 3.130. *Recovery of the entrance*

After the rock had been excavated from the trench and the surface levelled, the entrance to the structure was recovered. The mine rescue team surveyed the engineering structure (Figure 3.130). Based on these surveys, the volume and means of conducting the recovery work in the engineering structure, the order and duration of this work and safety measures in the structure were all clarified.

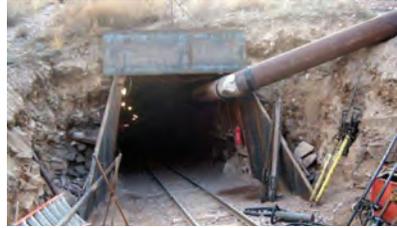
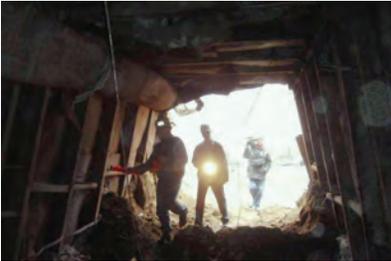
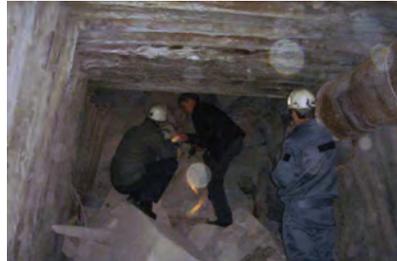
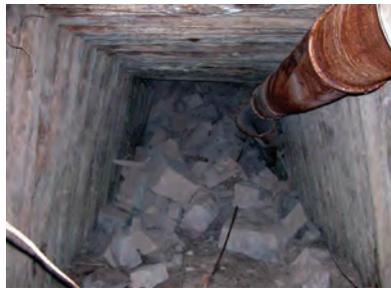
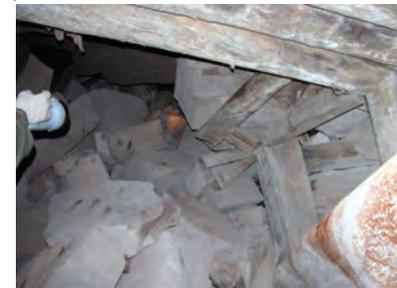
Opening of the entrance

View of the structure's entrance before and after development

Technical survey of the structure

Blockage of the structure upon its sealing

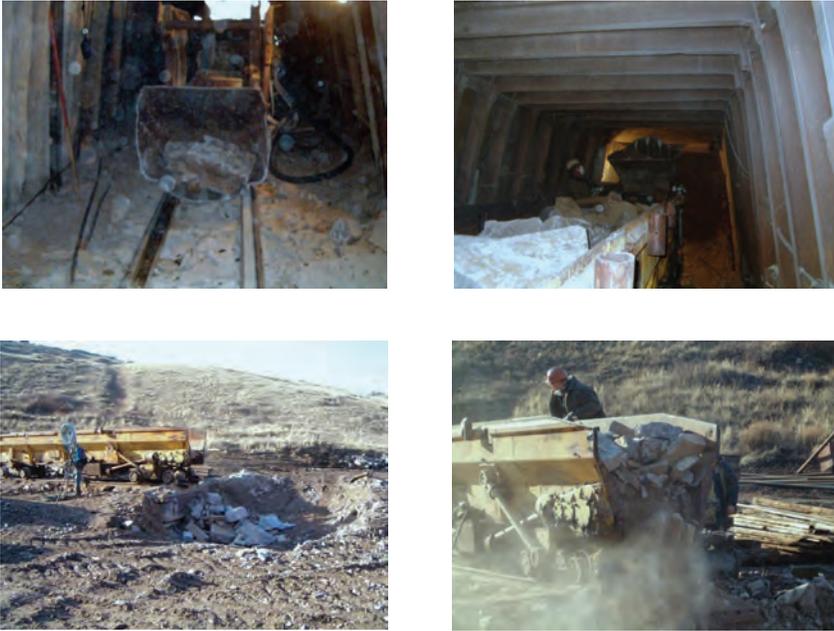
Figure 3.131. Removal of rock from the pile

After radiation monitoring, the rock was removed from the structure to a designated site within the working area (Figure 3.131).

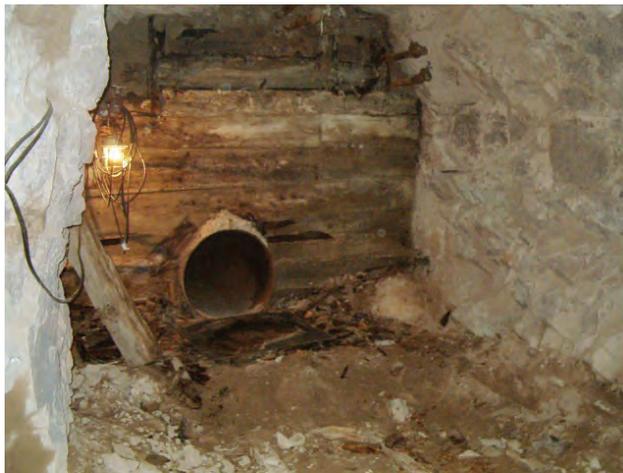
Figure 3.132. Hermetically sealed element with sealed access point at the elevation of 100 metres

At the elevation of 100–105 metres there is a hermetically sealed element with a sealed access point. The survey was performed through this sealed access point (Figure 3.132).

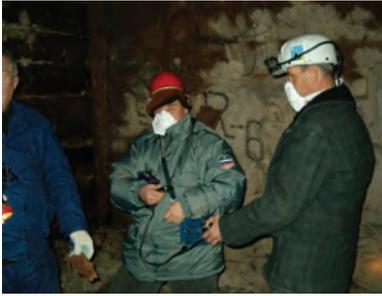
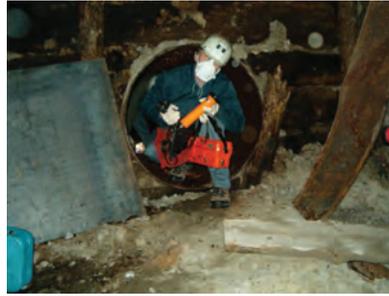
Figure 3.133. Survey of the section of the structure beyond the elevation at 105 metres

Russian specialists and operatives from the Radiation Safety and Ecology Institute examined the condition of the structure’s section beyond the plug (Figure 3.133). Similar work was performed at all sectors after the concrete safety plugs were opened and destroyed.

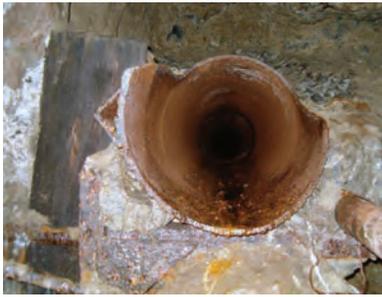
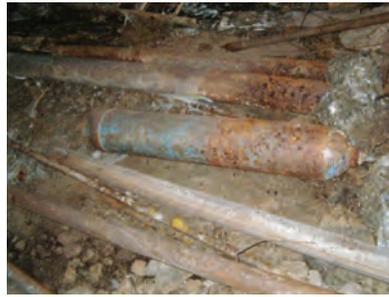
Figure 3.134. Traces of unauthorised presence

The examination revealed that the radiation situation was normal beyond this plug and discovered traces of unauthorised access by scrap-metal scavengers – cut tubes and used oxygen cylinders (Figure 3.134).

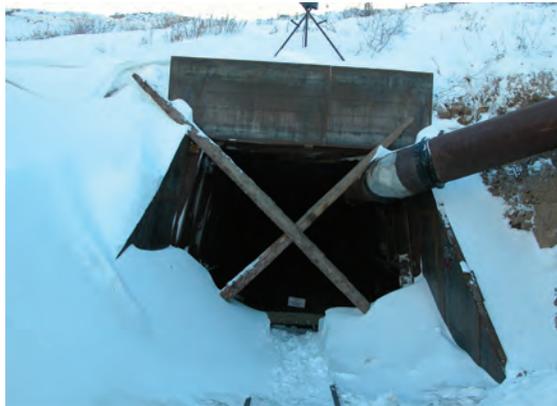
Figure 3.135. Sealed portal to engineering structure Y

After recovery of the section of the structure to the 130-metre mark, work at the site was suspended and continued at site X, while this site was sealed off and manned with a security presence (Figure 3.135).

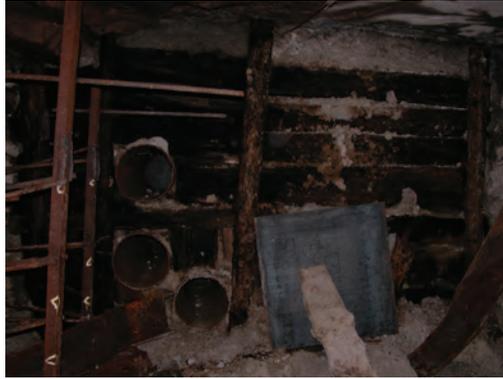
Figure 3.136. Hermetically sealed element with sealed access point at the survey mark at 140 metres

Concrete safety plugs were eradicated at the survey marks at 140–143 metres with sealed access point (Figure 3.136) and at the survey marks at 176–178, 184–186 and 190–195 metres.

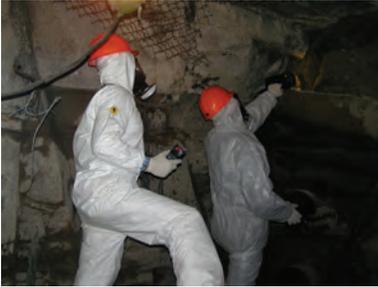
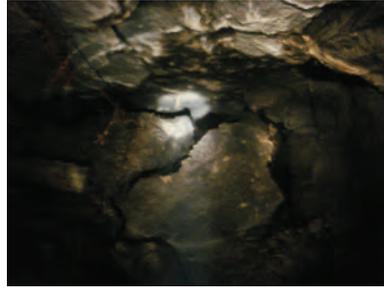
Figure 3.137. Examination of the concrete plug at the survey mark at 198 metres

The last plug before the box with fragments of special process equipment at the survey mark at 198 metres consisted of individual blocks of concrete (Figure 3.137). The radiation background by the wall of the plug at the 198-metre mark was increased.

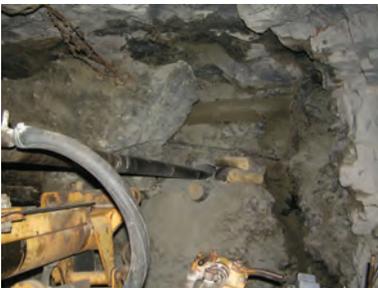
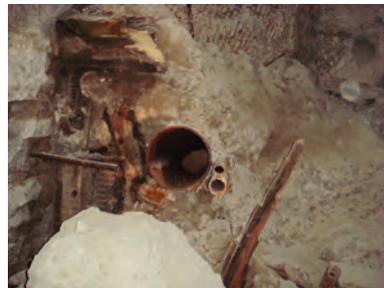
Figure 3.138. Boreholes to sample gases and for video surveillance

In the concrete plug at survey marks at 198–203 metres, a 105-mm-diameter borehole was drilled to a length of 5 metres to sample air from the atmosphere of the box. Then the borehole was drilled out to a diameter of 170 mm to deliver a video camera into the box and to conduct a survey (*Figure 3.138*).

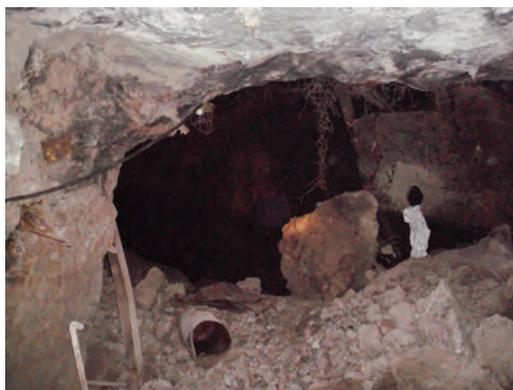
Figure 3.140. Box of the structure

A passage was arranged into the box through the point of access (*Figure 3.140*). On 20 April, Russian specialists surveyed the box, as a result of which fragments of the activated special process equipment were detected. According to the decision, adopted to reduce possible contamination of a considerable part of the structure, the fragments were packaged into a flexible container and taken away to the engineering structure at site X.

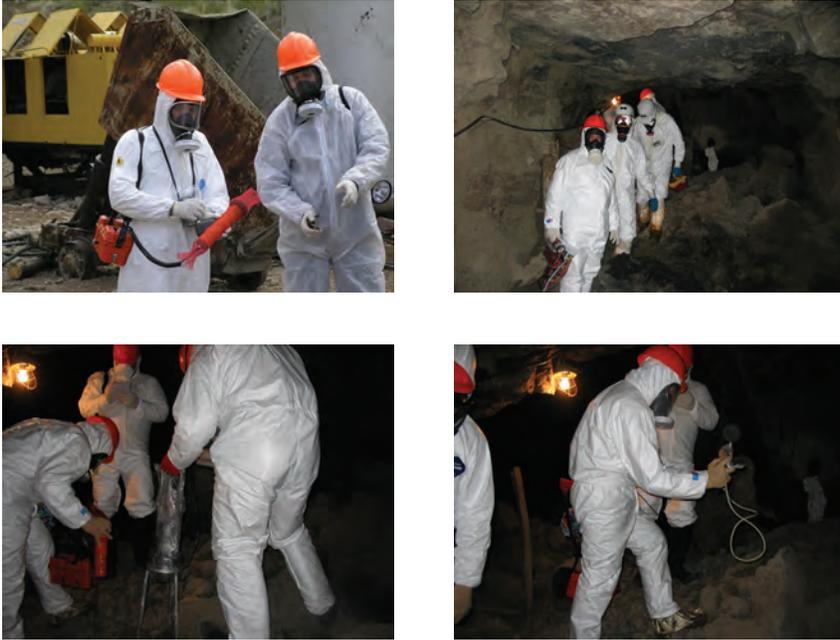
Figure 3.141. Survey of the box in the structure

US representatives were informed of the operation by e-mail. On 14 May, DTRA specialists arrived in Kurchatov and, on 15 May, a joint (trilateral) survey was performed on the box in the structure at site Y (*Figure 3.141*), as a result of which the presence of the special process equipment in the opened box was confirmed, as was the correctness of the decision to take it away to structure X for temporary storage,

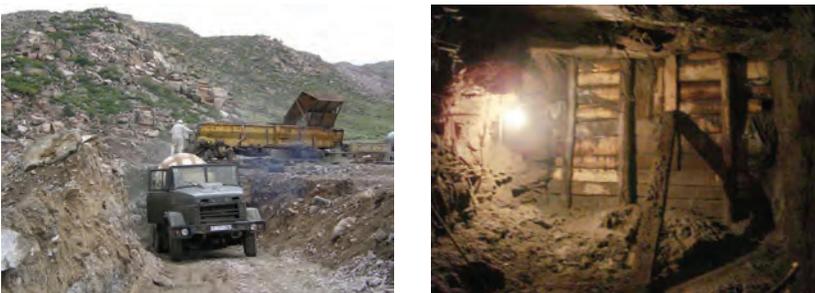
Wooden formwork was installed at the survey mark at 193 metres to fill the box and the section of the structure. The mortar, prepared using an ABS mixer, was delivered to the pouring point by a plugging car and loaded over a transporter to the BUK spreader (*Figure 3.142*). A total of 136 m³ of mortar was made and poured into the box.

Figure 3.142. Concrete pouring into the box

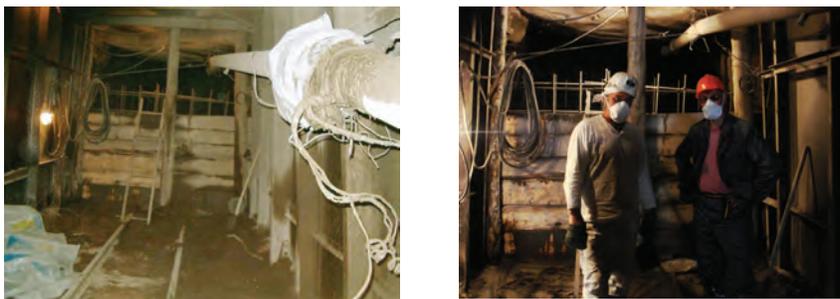
Figure 3.143. Installation of the concrete safety plug at 38–48 metres

A double set of wooden formwork was erected at the survey mark at 38–48 metres, between the walls of which a reinforcement metal mesh was installed all around the plug (Figure 3.143). The mortar was poured using a BUK-1 concrete spreader, located at the near-entrance area. A total of 92 m³ of mortar was poured into the plug at the survey mark at 38–48 metres.

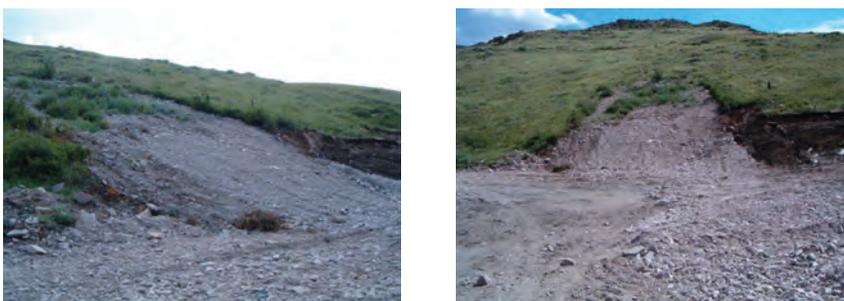
Figure 3.144. View of the site after closure

At the end of the work, the tunnel entrance and the near-entrance framework were dismantled and the structure’s cut-in trench backfilled with rock (Figure 3.144). A total of 550 m³ of rock was backfilled into the trench. A diagram of the structure after the work is presented in Figure 3.145.
