**SCIENTIFIC, TECHNICAL AND
ENGINEERING WORK TO ENSURE
THE SAFETY OF THE FORMER
SEMIPALATINSK TEST SITE**

Volume I

The first volume presents the results of scientific, technical and engineering work to ensure the safety of the former Semipalatinsk Test Site, also known as the *Polygon*, performed between 1994 and the present day by the National Nuclear Centre of the Republic of Kazakhstan, in collaboration with representatives of the United States of America and the Russian Federation. During the course of the work the nuclear testing infrastructure was abandoned and large-scale measures were implemented to mitigate the proliferation risks of weapons of mass destruction and prevent access to nuclear waste within the test site. The results of work on mitigating proliferation risks were given a high rating, as stated in a joint declaration by the presidents of Kazakhstan, Russia and the USA, pertaining to their collaboration at the former Semipalatinsk Test Site, made at the Nuclear Security Summit in Seoul on 27 March 2012.

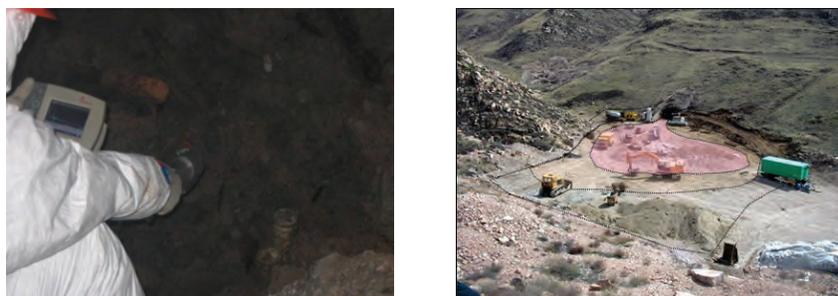
Figure 3.148. Inspection of the tunnel bottom using a portable gamma-spectrometer

The bottom of the tunnel and equipment were periodically inspected using a portable gamma-spectrometer during the course of the work (*Figure 3.148*).

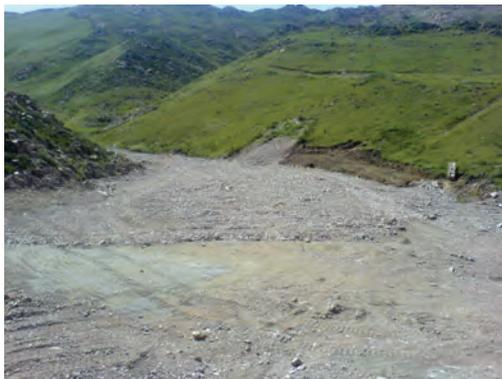
Figure 3.150. Overview of the area at site Y after completion of the work

During the reclamation of the area, operational spectrometric monitoring of the crushed aggregate and the contaminated sector was performed. Evidence of the quality of the work was the lack of a ^{241}Am peak at the backfilled area. As a result, the entire area was backfilled with a layer of crushed aggregate (*Figure 3.150*). The height of the backfilling varied from 10 to 25 cm, depending upon the initial level of the radiation contamination.

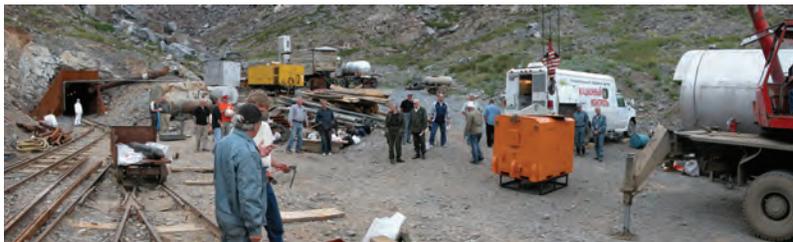
Figure 3.154. Transport container at the working area

On 6 June 2007, the transport container was delivered by road from Kurchatov to the working area of site X (*Figure 3.154*).

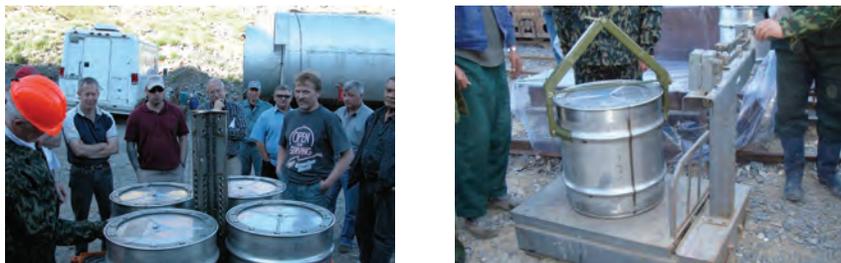
Figure 3.155. Weighing AT-400 R containers before material was added

Empty AT-400 R containers were weighed and inspected at the working site (*Figure 3.155*).

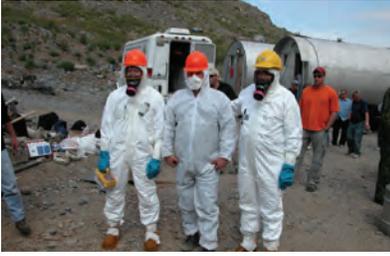
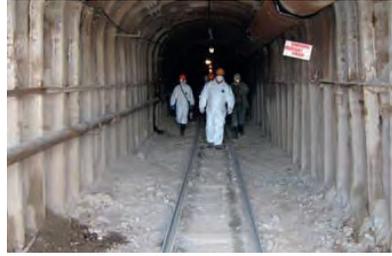
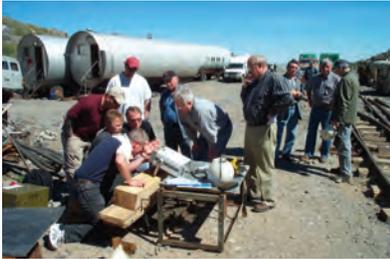
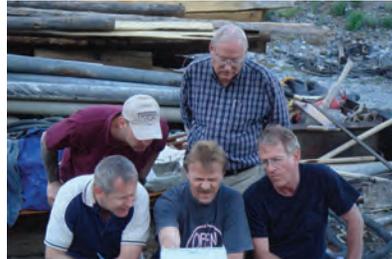
Figure 3.156. Survey of the box in the structure

Personnel involved in surveying the box in the structure

Radiometric measurements of the containers

American and Russian specialists, with dosimetric monitoring performed by NNC operatives, inspected the box of site X after extracting the special process equipment and conducted the necessary radiometric measurements (*Figure 3.156*).

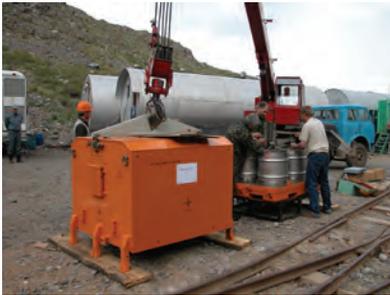
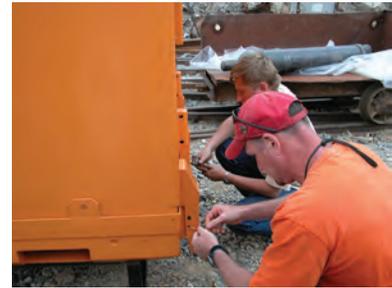
Figure 3.157. Russian and American specialists closing and sealing the containers

The AT-400 R containers were placed in the transport container, their lids closed and sealed by Russian and American specialists (*Figure 3.157*).

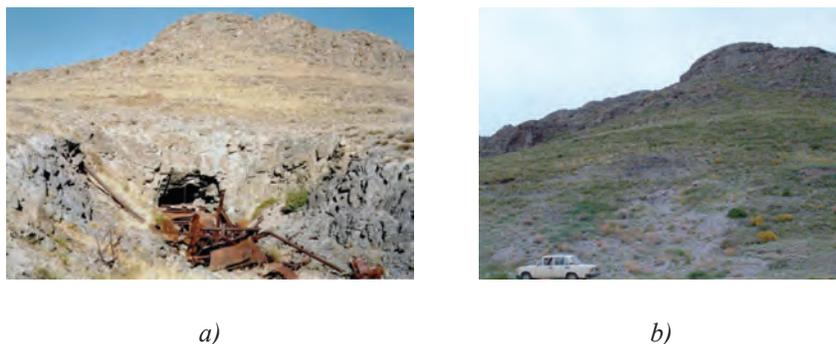
Figure 3.162. View of the structure's entrance before (a) and after (b) closure

The structure at site Z was closed on 2 October 1997 by drilling and blasting from outside. The collapsed section stretched for 15 metres. The portal into the engineering structure was backfilled with fine rock and concealed under the surrounding landscape (*Figure 3.162*).

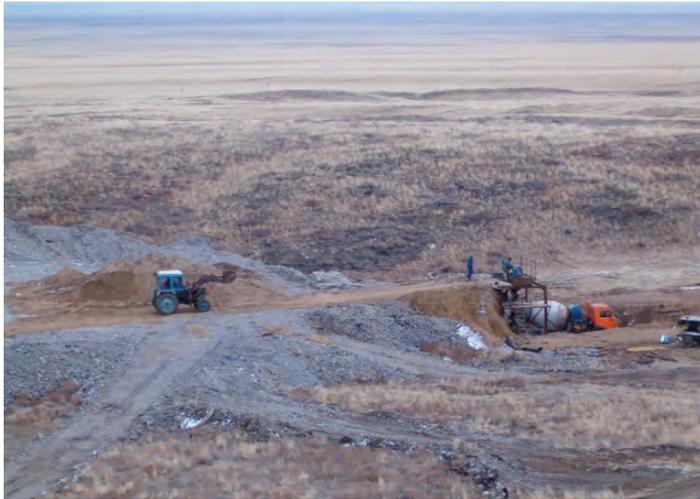
Figure 3.168. Area for stockpiling the sand and gravel mix, cement and magnetite

The proportioning of the components and preparation of the concrete and the sand-magnetite solutions were performed at the concrete and mortar facilities. The heap of rock from the structure was used for the construction. A storage facility was arranged in the area to store inert materials, cement and magnetite (*Figure 3.168*). Work began on drilling exploratory boreholes with a diameter of 105 mm from Box No. 2, located

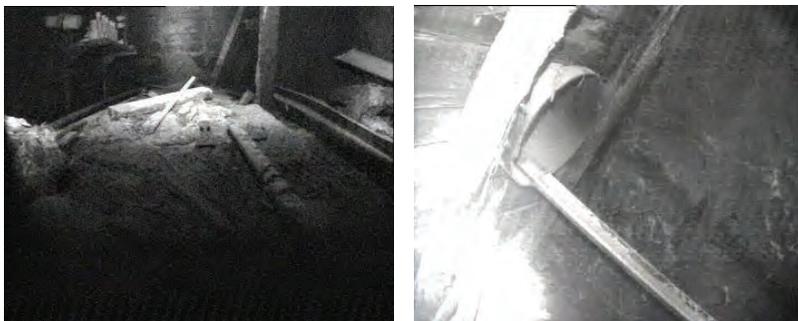
Figure 3.171. View of Box No. 1

The video surveillance helped to determine the location of special boreholes for the concreting. A drilled borehole with a diameter of 105 mm entered the structure (determined by the tool string sinking and no more drill mud or air emerging onto the surface). At first, the borehole was used to measure the levels of activity. The measurement data determined the radioecological situation in the box of the structure to be higher than normal. After the video surveillance it was established that the box is about 8 metres long. Also, there were fragments of some devices visible in the box and evidence was discovered of unauthorised access into the box through a pipe in the top left corner of the protective wall (*Figure 3.171*).

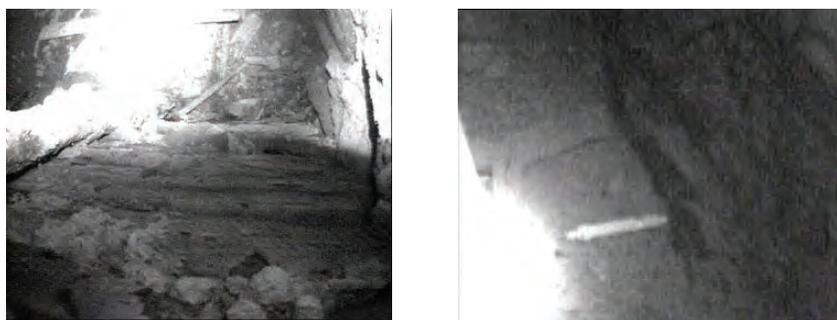
Figure 3.172. Situation in Box No. 3

borehole. The measurements indicated increased levels of activity in this box. Video surveillance confirmed the need to pour concrete specifically into this box (*Figure 3.172*).

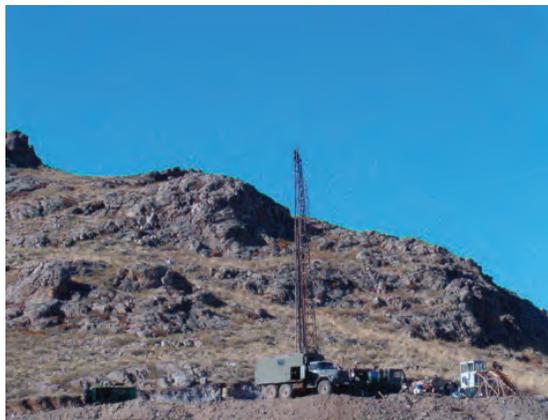
Figure 3.174. The drill rig at the working area

The vertical boreholes for work in Box No. 2 were drilled using an URB-3AM drill rig, mounted on a KamAZ truck (*Figure 3.174*). Inclined boreholes were bored using a TEJ drill rig, with a wide range of incline angles (*Figure 3.175*).

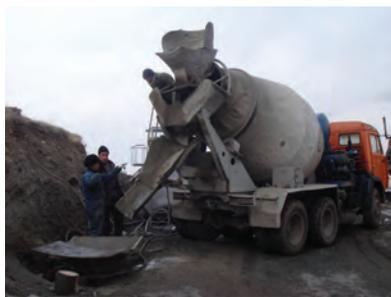
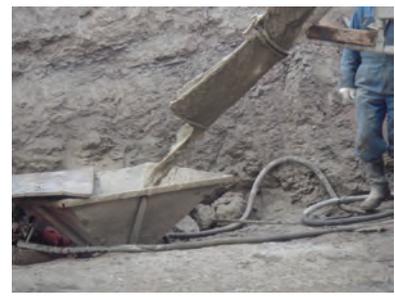
Figure 3.176. *Pouring solutions into the boxes*

The ready concrete mix and the sand-magnetite solution were delivered to the near-entrance area in ABS-5 cement mixer trucks. The concrete mix was unloaded into the receiving funnels of the boreholes using discharge devices (*Figure 3.176*).

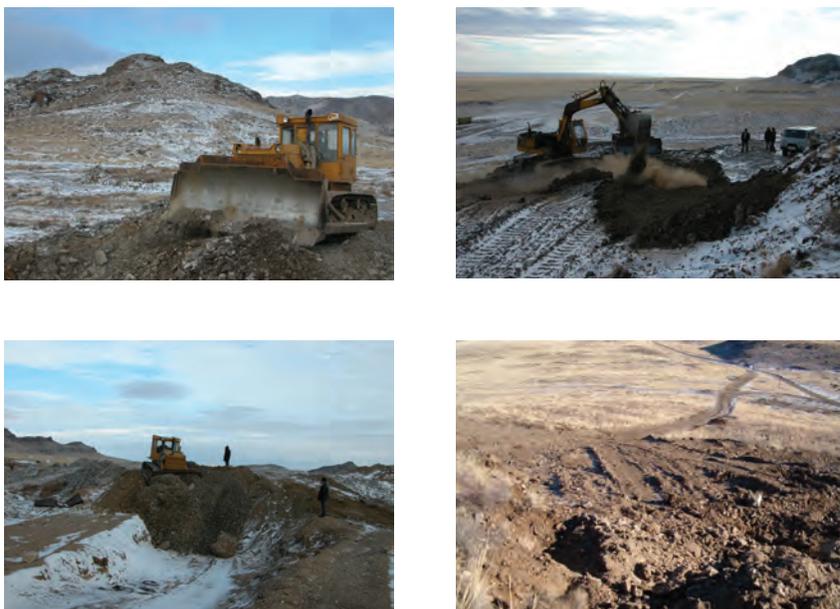
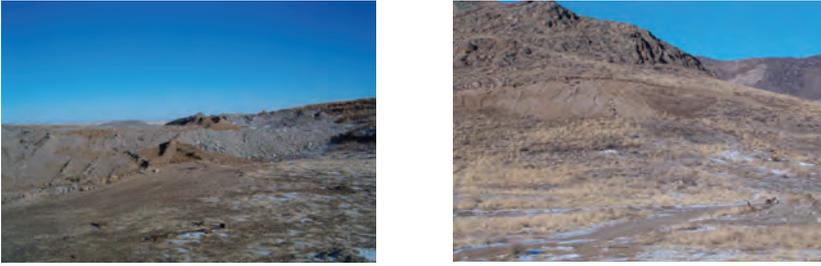
Figure 3.180. Reclamation of the area

After completion of the work on site, reclamation work proceeded at the working area, the access roads and the camp with the concrete and mortar facilities (*Figure 3.180*). The working area and the roads were backfilled with earth with a large fertile soil content, which is particularly favourable for grassy vegetation.

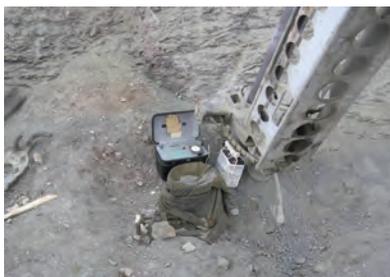
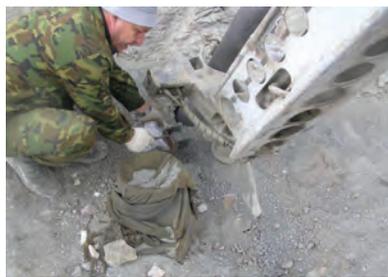
Figure 3.181. Measurement of equivalent equilibrium volume activity in terms of radon and thoron at the working area

Maximum equivalent equilibrium volume activity in terms of radon and thoron was within permissible levels (*Figure 3.181*).

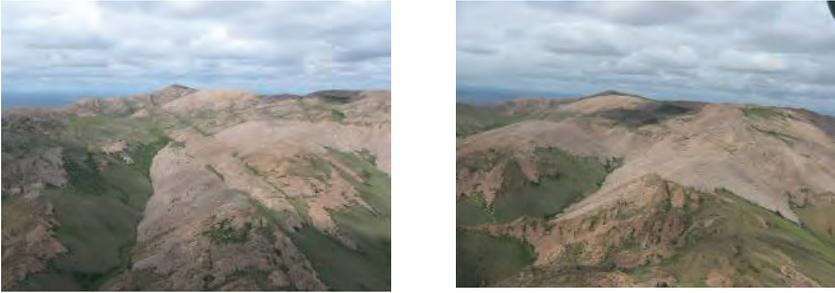
Figure 3.189. Mountain relief over the epicentres of blasts (view from a helicopter)

As a result of the tests conducted, the relief of the mountain over many end boxes of the structures was disturbed (*Figure 3.189*).

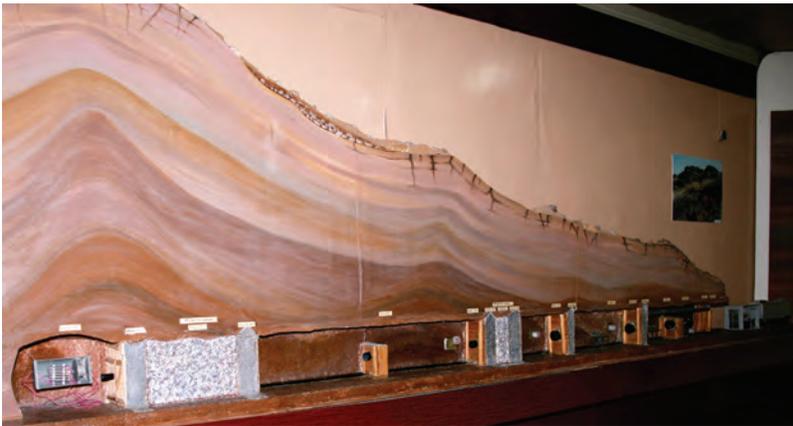
Figure 3.190. Model of an engineering structure

The engineering structures at the sites at Degelen Mountain are voluminous, linear, underground structural systems (mine workings), designed for nuclear weapons testing and for the temporary presence of personnel to assemble equipment and constructions when preparing for the tests (*Figure 3.190*).

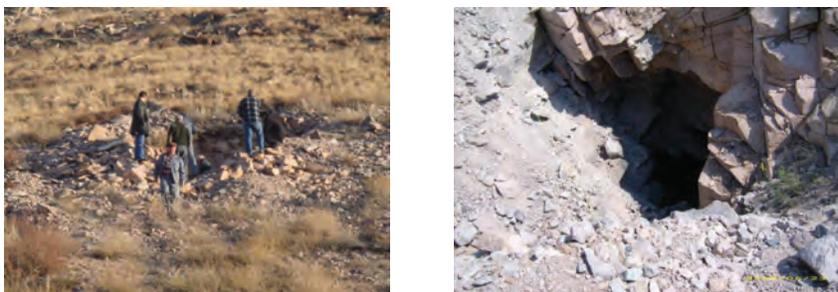
Figure 3.194. Access point at the entrance to site D1

Within the entrance at site D1 there is an access point, joining the surface with the structure (*Figure 3.194*).

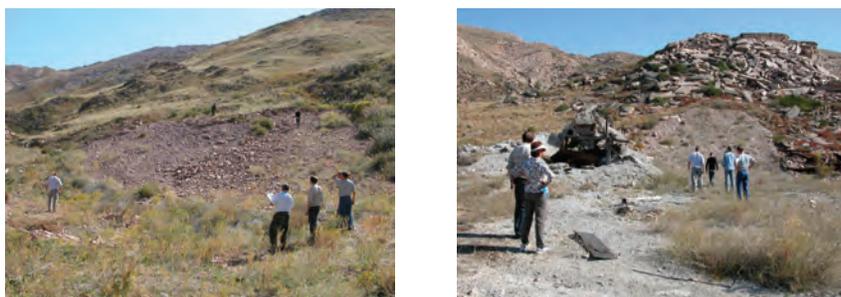
Figure 3.195. View of the site entrances

No access attempts were discovered within the entrances to structures D3 and D5 (*Figure 3.195*).

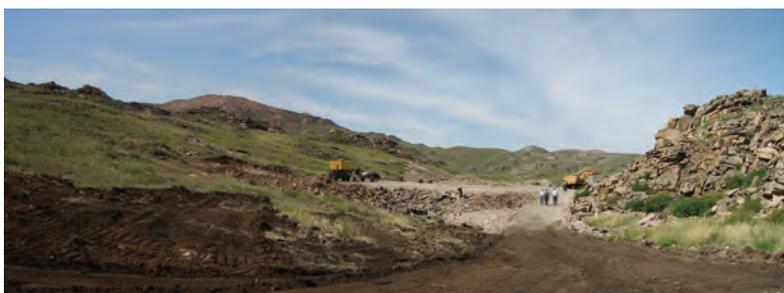
**Figure 3.196.** *Working area at site D1*

Proceeding from radiometric survey data on the mountain area lying adjacent to the mouth of the tunnel at site D1, the location for the working area and the access road was selected (*Figure 3.196*).

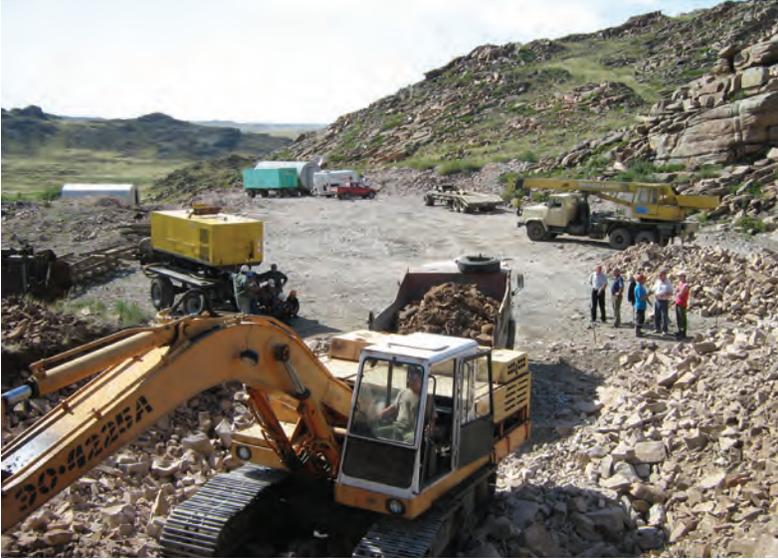
Figure 3.197. Laying out the area at site D1

The area was laid out to locate the mining and power complexes, the equipment, necessary mechanisms and trailers. The dimensions of the near-entrance area and the volume of the layout work depended on the relief of the locality where the work was performed (*Figure 3.197*).

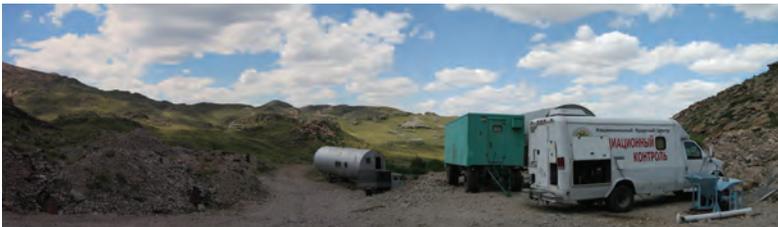
Figure 3.198. Radiation monitoring room

- a ZUK-type battery charger facility with equipment to charge and maintain batteries for the AM-8D electric locomotive, installed pursuant to Electrical Installation Code (PUE) 6 (supplemented and revised);
- a decontamination room for personnel to change (protective clothing for work in the engineering structure’s *clean zone*);
- a decontamination station for the personnel with a hot water supply;
- a radiation monitoring room where personnel are subjected to dosimetric monitoring and where levels of radioactive contamination of the external surfaces of equipment and apparatus are measured (*Figure 3.198*).

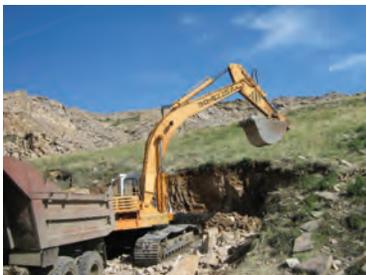
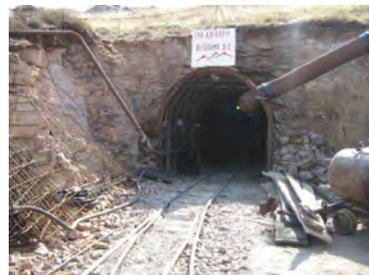
Figure 3.200. Opening and constructing the cut-in trench and assembly of frame work near the entrance

The engineering structure was opened up by constructing a new cut-in trench and entrance (*Figure 3.200*).

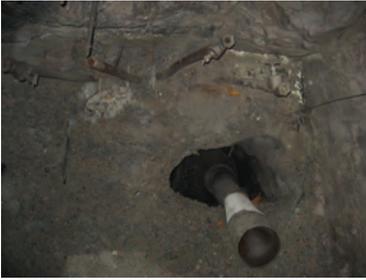
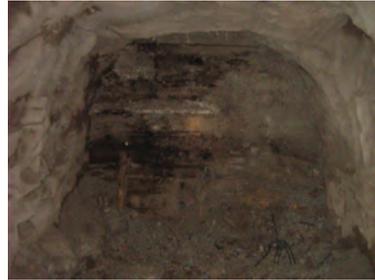
Figure 3.201. Dismantling protective elements

Existing protective elements in the structure's main shaft were dismantled for access to the PB containment vessel (*Figure 3.201*).

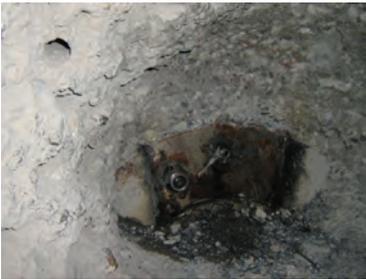
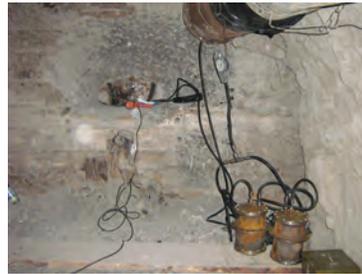
Figure 3.202. Opening the protective containment vessel

The free space in the PB containment vessel was opened up by drilling holes through into its top, using a device to prevent loss of containment (*Figure 3.202*).

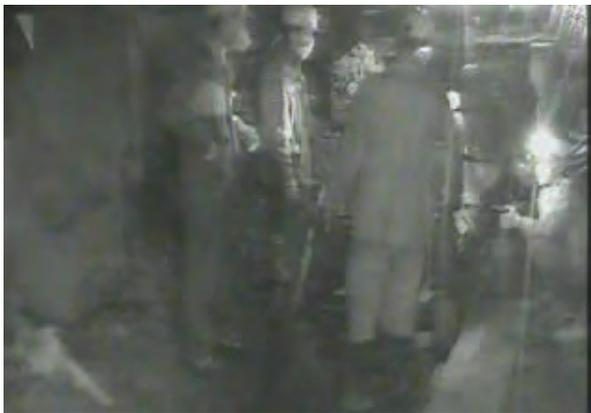
Figure 3.203. Filling the protective containment vessel

After verification measures, work began on filling the protective containment vessel (*Figure 3.203*).

The free space in the PB containment vessel was filled with a binding solution. The gaseous mixture that was expelled during the filling process was filtered through cermet filters of the bleed system, supplied by VNIITF and released onto the daylight surface by the regular ventilation system.

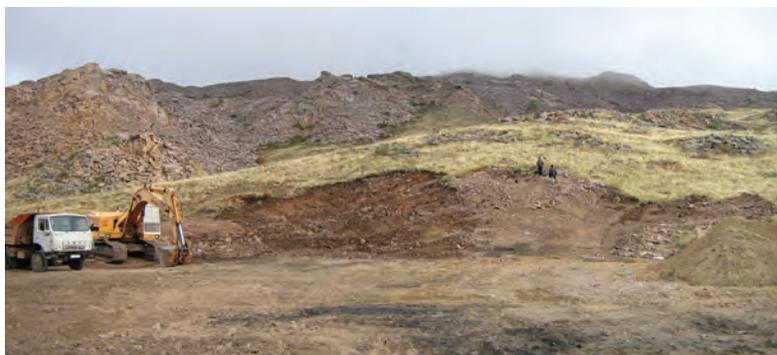
Figure 3.204. *Altering the relief up to the natural landscape*

The new entrance and cut-in trench were backfilled and concealed beneath the surrounding landscape (*Figure 3.204*).

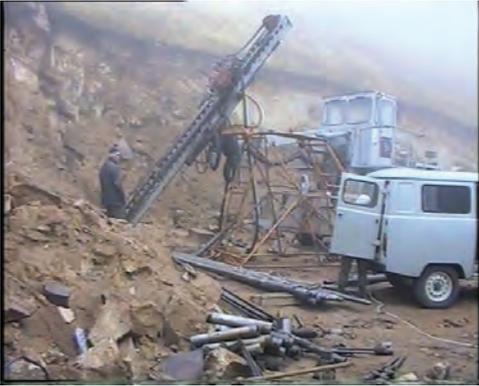
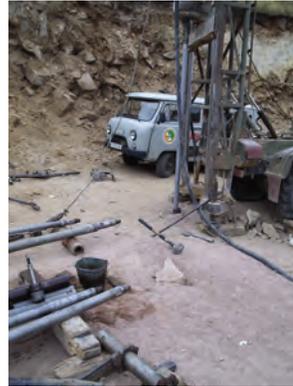
Figure 3.206. Vertical drilling into the tunnel cavity

Step 2: Vertical drilling into the structure. Expert confirmation was obtained that entry had been made into the corresponding locations and that there was nuclear waste within them. Drilling work into the tunnel cavity is presented in *Figure 3.206*.

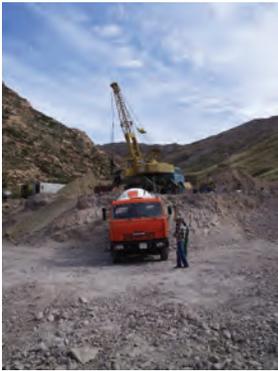
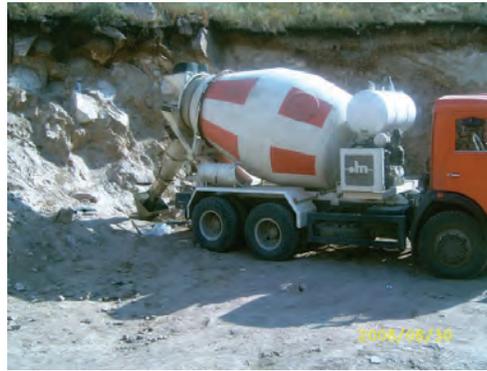
Preparation of mortar at the concrete and mortar facilities and pouring the magnetite solution

Step 3: The requisite sections were filled with cement mortar/concrete with subsequent recovery of the working area (*Figure 3.208*).

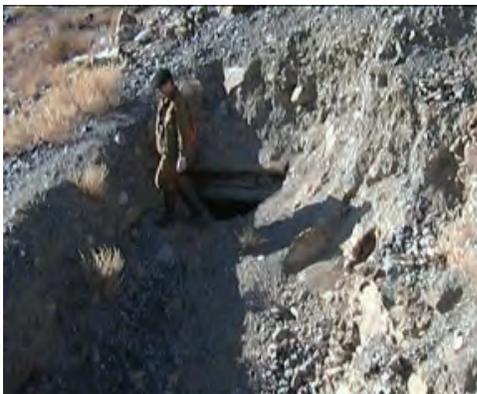
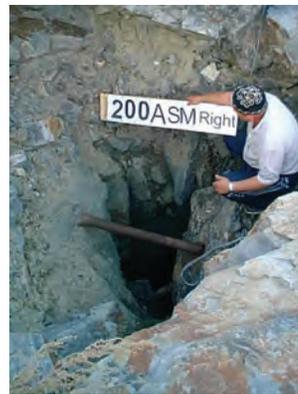
Figure 3.212. Traces of unauthorised access to tunnels (access points)

- access points, meaning possible entry into the tunnels, were found at 72 sites, where 35 structures had evidence of actual access, while the remaining 37 entrances had access points of only insignificant dimensions;

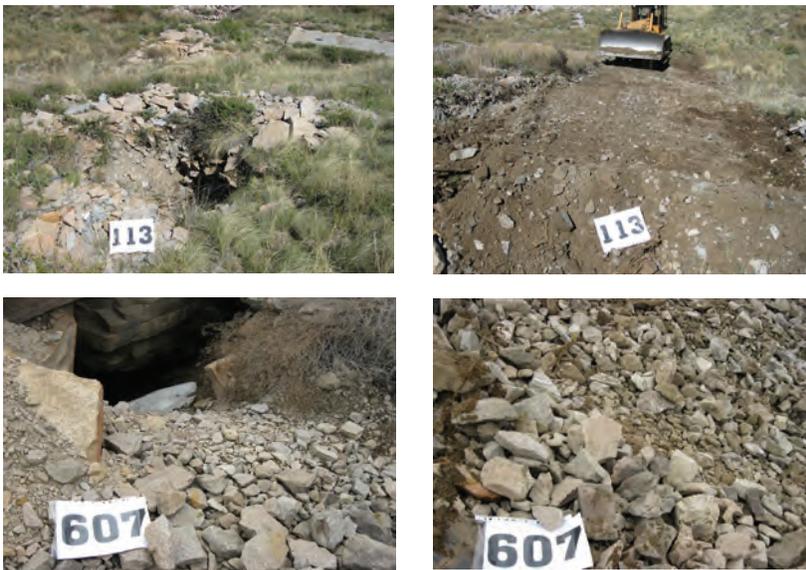
Figure 3.213. An example of strengthened protection at certain engineering structures

Between 2008 and 2012, NNC implemented a number of measures to eradicate traces of human activity at the tunnel entrances at Degelen Mountain. Work was performed to strengthen the protection at 57 engineering structures (*Figure 3.213*).

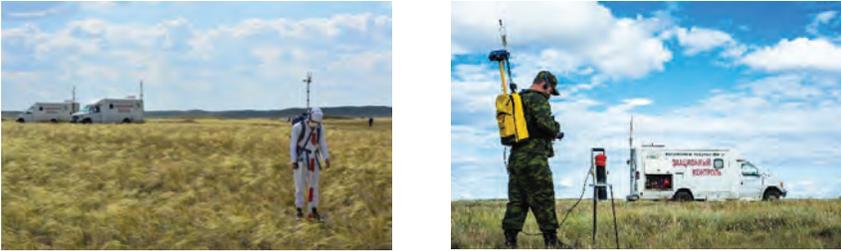
Figure 3.218. Gamma-spectrometry survey on foot at the Experimental Field

the area in question; 2) detailed description of sections with abnormally high concentrations of ^{241}Am and ^{137}Cs ; 3) calculation of the reserves of nuclear waste at the discovered sections. A gamma-spectrometry survey was performed on foot for a general assessment of the distribution of radionuclides over the area in question, over sectors (moving over set coordinates), with a 20-metre distance between sectors (*Figure 3.218*).

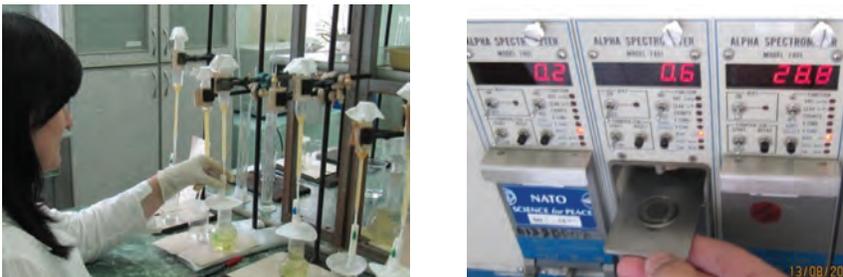
Figure 3.219. Laboratory studies

To do this, the vertical distribution of radionuclides in the subsurface was studied based on the results of laboratory measurements of soil samples layer by layer (*Figure 3.219*). In addition, the relationships between $^{239}\text{Pu}/^{241}\text{Am}$ and $^{235}\text{U}/^{241}\text{Am}$, which lay at the heart of the gauging of nuclear waste quantities, were calculated.

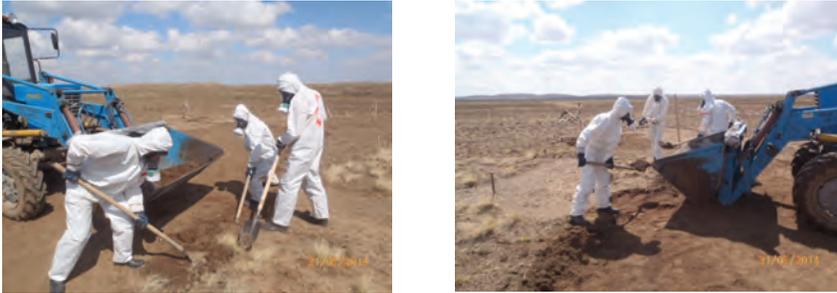
Figure 3.229. Nuclear waste extraction

The nuclear waste was extracted manually (*Figure 3.229*).

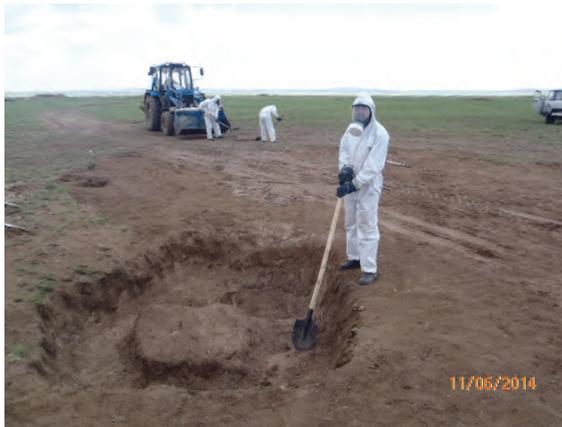
Figure 3.230. Adjusting extraction depths based on the results of real-time monitoring

Manual extraction helped reduce the depth of earth extraction which, in turn, reduced the volumes of the extracted nuclear waste. In addition, the dimensions of the sectors were adjusted (upwards), which guaranteed the extraction of nuclear waste with values over 8 ppm. At the same time, the activity of the soil, after removal of the top layer, was controlled by a spectrometrist at the work site. If certain values of total activity were higher (based on spectrometer readings (cps) to ppm), the earth was extracted at a greater depth (*Figure 3.230*) and, in some cases, beyond the initially set perimeter of the sector, until values of nuclear waste content were lower than 8 ppm.

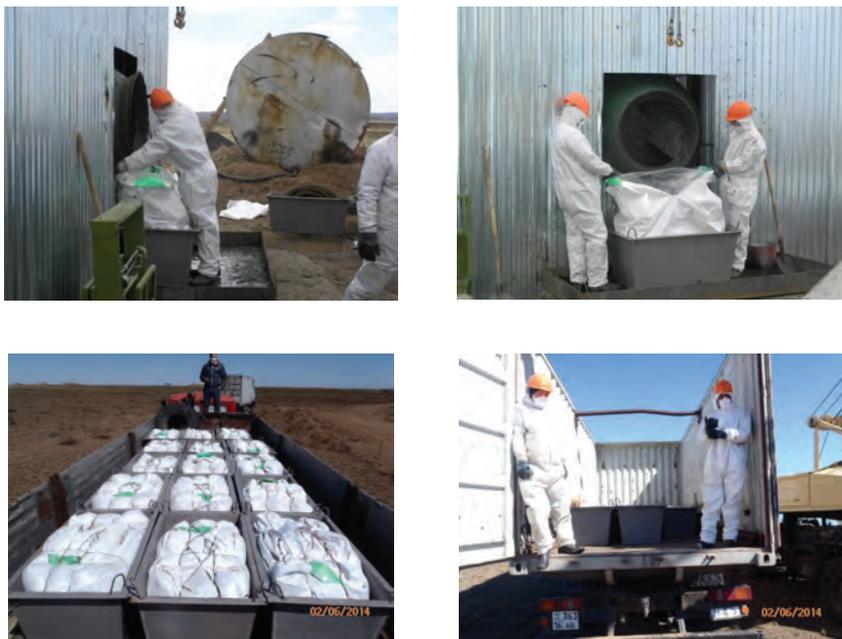
Figure 3.231. Making up and placement of packaging containers for transport to the radioactive waste storage facility

The ground extracted from sectors 2, 12 and 13, after processing, was placed in transport packaging containers for onward transport to the storage site (*Figure 3.231*). A total of 346 transport packaging containers were prepared with a total volume of 86.5 m³.

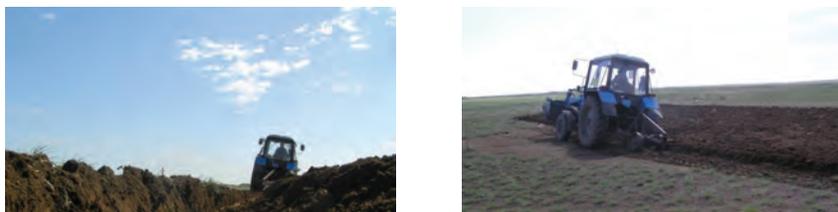
Figure 3.232. Ploughing over the sectors

The earth was tilled (ploughed) to a depth of 40–50 cm (*Figure 3.232*).

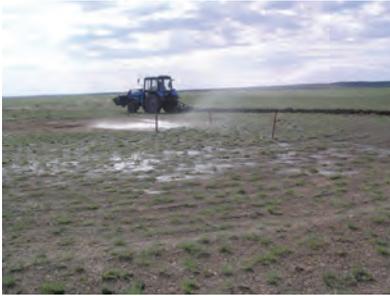
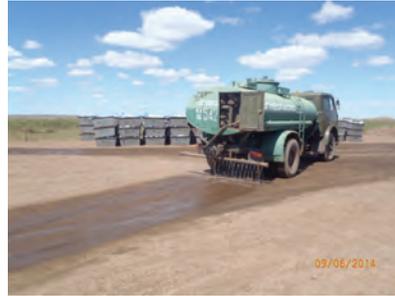
Figure 3.234. Irrigating the sector for tilling and the working area

As the entire process, from the extraction of the soil to the making up of the packaging containers, involved the rising of dust, the roads, extraction sites and working areas were wetted throughout the course of each working shift. The sectors were also thoroughly watered prior to the tilling of the earth. This irrigation almost completely prevented dusting (*Figure 3.234*).

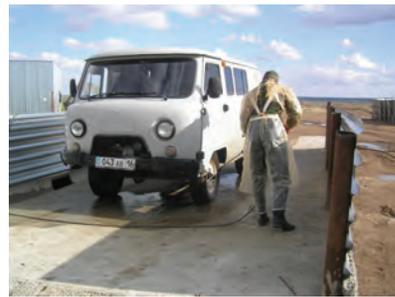
Figure 3.235. Examination and decontamination of a vehicle

When equipment needed to travel out onto provisionally clean territory, a radiometric examination was performed and, if necessary, decontamination measures were applied (*Figure 3.235*).

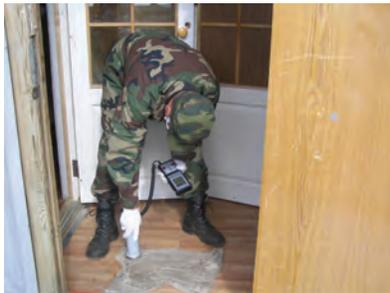
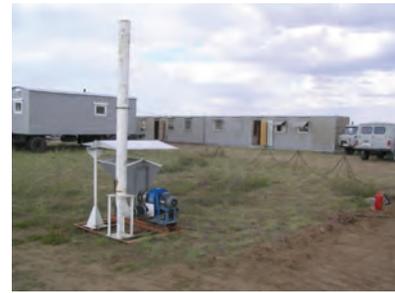
Figure 3.236. Radiation monitoring of the residential zone

Radiation monitoring of air contamination with industrial radionuclides was conducted where the work itself was performed and where the personnel resided. The air was monitored using electromechanical air-sampling devices, which settle airborne aerosols onto the filtering element (filter) (*Figure 3.236*).

The content of industrial radionuclides ^{241}Am and ^{137}Cs in the air of the residential zone over the entire period of the work did not exceed 2.0×10^{-4} and 6.5×10^{-5} Bq/m³ respectively, which is no higher than the permissible volume activity for personnel according to normative requirements. The content of the radionuclide $^{239+240}\text{Pu}$ in the air of the residential zone is likewise within the level of the permissible volume activity for personnel.

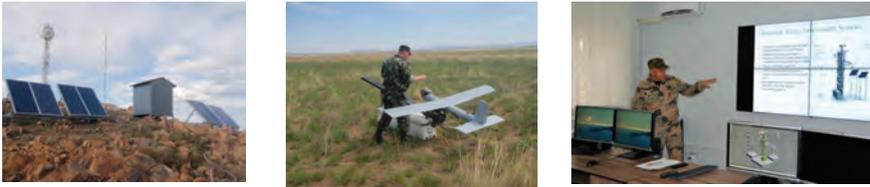
Figure 3.237. *Physical protection system at Degelen Mountain*

The systems have been installed at sites, located from 80 to 200 km from Kurchatov (*Figure 3.237*).

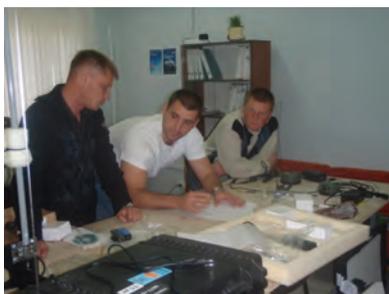
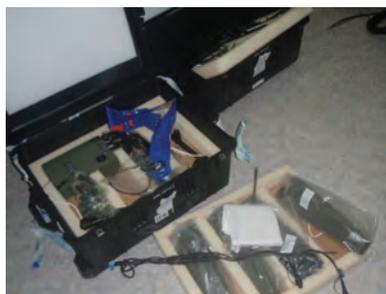
Figure 3.239. System equipment

Detection system. In accordance with the Works Plan, NNC procured an automatic, terrestrial, remote control system. The supplier delivered the equipment (*Figure 3.239*) to Kurchatov. Specialists from the equipment manufacturer came to Kurchatov to test and complete the initial installation of the equipment.

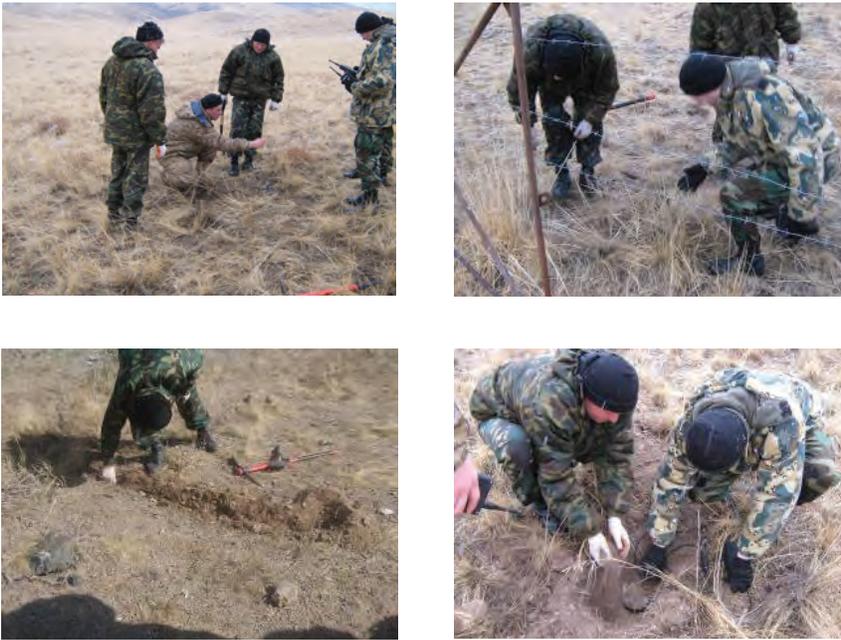
Figure 3.240. *Installation and concealment of detectors*

Allowing for the relief of the locality and the distance involved, secure sites were selected where detectors were installed (*Figure 3.240*). The system was configured and tested and the personnel were trained.

Detectors operating as relays were installed to increase the communication range and to compensate signal deterioration at intermediate altitudes.

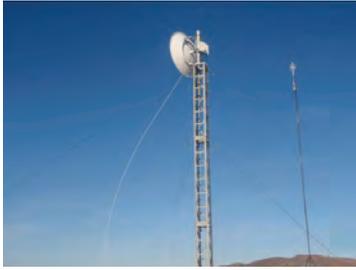
Figure 3.241. Antennae, installed at altitude point 1008

The system operation is served by a relay, installed within Degelen Mountain, at an altitude of about 1,000 metres (*Figure 3.241*).

The relay is housed in a sealed metal box. The fixed antenna is installed on an 8-metre mast. The power for the relay is supplied from an autonomous, uninterrupted power supply.

The positioning of the relay at the highest point of the mountain ensured the maximum radius of coverage. In other words, network users with handheld radio stations were able to communicate all over Degelen Mountain and over the entire route to Kurchatov. *Figure 3.242* displays the GM-340 radio station with power unit.

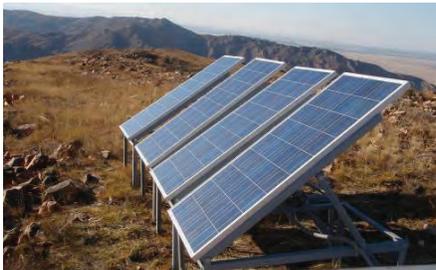
Figure 3.243. Solar panels

The autonomous power supply system equipment was installed at the top of the mountain. Solar panels with a total power capacity of 520 W/hr were installed on purpose-built structures, enabling adjustment of inclination angle relative to the horizon. The panels of the operating surface are directed southwards. The inclination angle was set at 45° (Figure 3.243).

2. The autonomous power supply system – the system capacity was designed for performance of existing tasks. A check was needed of the operability of the system in winter conditions. It is advisable to divide the power supply systems between the radio communication and data transmission equipment to ensure the energy independence of the systems. If the user capacity is increased, the system would need to be expanded (with the acquisition of additional solar panels, replacement of controllers and inverters and the addition of a petrol generator to the system with a remote start facility). Consideration should also be given to the use of a wind generator as an additional power source.

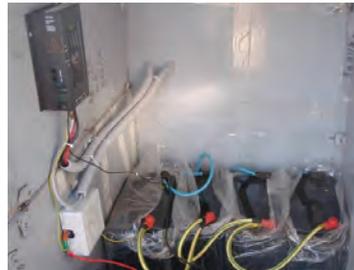
Figure 3.244. Battery and solar charge controller

The electricity produced by the solar panels, through the solar charge controller, charges the batteries with a total capacity of 580 A/hr. 220V equipment is powered through an inverter, connected to the battery (Figure 3.244).

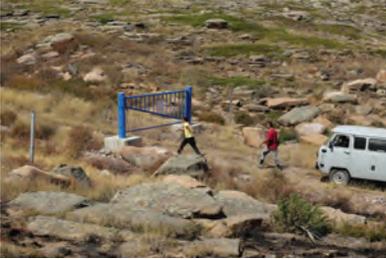
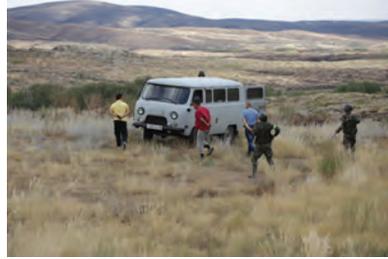
1. An inspection of the technical detection systems upon attempts by a simulated trespasser to gain access to the secure site (*figures 3.245 and 3.246*).
2. An assessment of the round-the-clock operation of the systems, the control, communication and computer equipment and cooperation between those involved in the process (*Figure 3.247*).

Figure 3.245. Attempts by simulated trespassers to gain access

Figure 3.246. Detention of simulated trespassers

The comprehensive inspection demonstrated the high effectiveness of detection, control, communication and computing system facilities (both during the day and at night) and also of effective cooperation between parties involved in the process.
